Access Compliance Report

Public Rights-of-Way

(Curb Ramps)

Intersection ID: 11309	Main Street: MASON_CR	Cross Street: THE_PLAZA	Location: S
ADA ID: 0BB5DC1A737E	Ramp Type: Perp	Initial Pass/Fail: Fail	Overall Compliance: No
Severity Score: 21.25			
Codes/Mitigation Info/Possible Solution		Field Measurements/Component Compliance

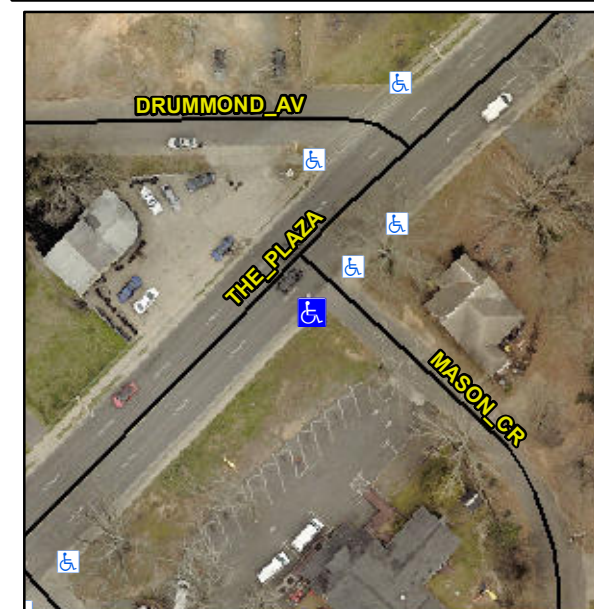
Not Found, R304.5.1, R304.2.2

Compliance	Description	Data	Compliance	Description	Data
N/A	Ramp Length (in)	38.0	No	Ramp Slope (%)	8.4
No	Ramp Width (in)	43.0	Yes	Ramp XSlope (%)	0.1
N/A	Flare Type LT	N/A	N/A	Flare Type RT	N/A
N/A	Flare Slope LT (%)	N/A	N/A	Flare Slope RT (%)	N/A
N/A	Flare Traversable LT?	N/A	N/A	Flare Traversable RT?	N/A
N/A	Landing Length (in)	N/A	N/A	DWS Provided?	N/A
N/A	Landing Width (in)	N/A	N/A	DWS Contrast?	N/A
N/A	Landing Slope (%)	N/A	N/A	DWS Length (in)	N/A
N/A	Landing X Slope (%)	N/A	N/A	DWS Full Width?	N/A
N/A	Landing Curb? (Y/N)	N/A	N/A	DWS Offset (in)	N/A
N/A	Shared Landing?	N/A			
N/A	Gutter Ponding?	N/A	N/A	Gutter Slope (%)	N/A
N/A	Gutter Lip Ht (in)	N/A	N/A	Gutter X Slope (%)	N/A
N/A	Painted X Walk1?	No	N/A	Painted X Walk2?	N/A
	X Walk 1 Direction	To NE		X Walk 2 Direction	N/A
N/A	X Walk 1 Width (in)	N/A	N/A	X Walk 2 Width (in)	N/A
	X Walk 1 Slope (%)	1.0		X Walk 2 Slope (%)	N/A
	X Walk 1 X Slope (%)	1.2		X Walk 2 X Slope (%)	N/A

N/A	Ramp inside XWalk1?	N/A	N/A	Ramp inside XWalk2?	N/A
	Road Slope (%)	N/A	N/A	Clear Space?	N/A
	Road X Slope (%)	N/A	N/A	Clear Space to XWalk (in)	N/A
N/A	Any Obstructions?	N/A	N/A	Storm Grate/Utility Hazard?	N/A
	Obstruction Type			Storm Grate/Utility Type	
		N/A			N/A
			Yes	Surface Condition? (G/P)	Good

Possible Solutions:

Remove & Replace Entire Ramp.
