## **Access Compliance Report Public Rights-of-Way** (Curb Ramps)

Intersection ID: 45500 Main Street: GRASSY CROPS RD **Cross Street: TRIPLE OAK RD** Location: SE ADA ID: 0BB68BEDFD9A Ramp Type: Perp Initial Pass/Fail: Fail **Overall Compliance: No Severity Score:** 35

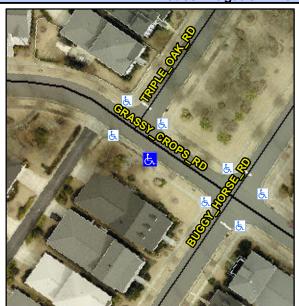
**GRASSY CROPS RD** Street 1 Name Stop Condition-Street 2 None Street 2 Name N/A Stop Condition-Street 1 N/A

| Field Measurements/Component Compliance | | | | | |
|---|---|---|---|---|---|
| N/A | Ramp Length (in) | 48.0 | No | Ramp Slope (%) | 13.7 |
| No | Ramp Width (in) | 47.0 | Yes | Ramp XSlope (%) | 2.8 |

Possible Solutions: Remove & Replace Entire Ramp. Surveyor Notes: N/A PROW/ADA: Not Found, R304.5.1, R304.2.2
