Access Compliance Report Public Rights-of-Way (Curb Ramps)

Intersection ID: 10015853 Main Street: STATESVILLE_AV Cross Street: N/A Location: E

Ramp Type: BlendTrans1

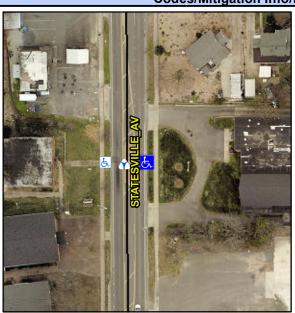
Overall Compliance: No

NO CURB LINE, DWS OS MEASURED TO ASP

Remove & Replace Curb Ramp With Two New Directional Ramps or Equivalent.

R304.2.2-Perp, R304.3.2-Para, R305.1.4, R305.2
