# Access Compliance Report

## Public Rights-of-Way

| Intersection ID: 10735 | Main Street: N_DAVIDSON_ST | Cross Street: E_27TH_ST | Location: E |
| ADA ID: 0BC42255B47E | Ramp Type: Perp | Initial Pass/Fail: Pass | Overall Compliance: No |

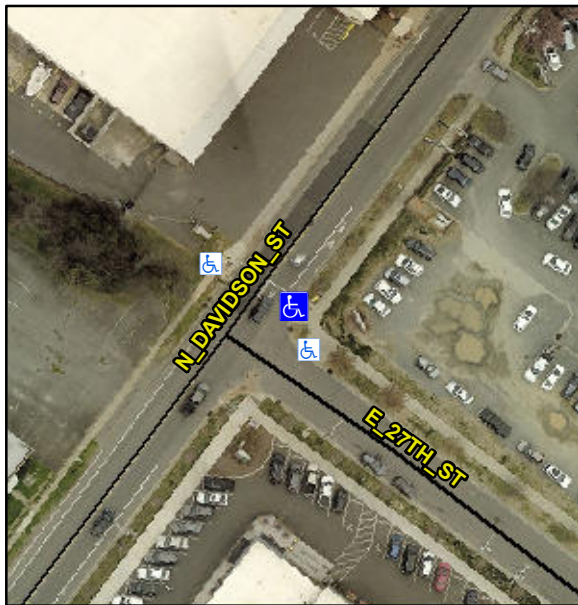
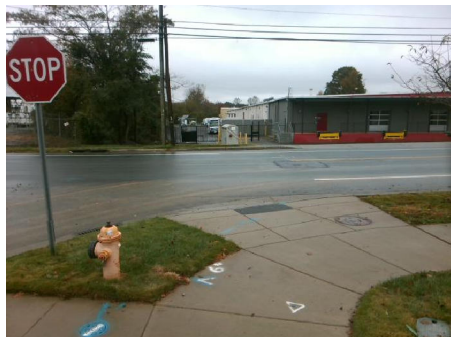
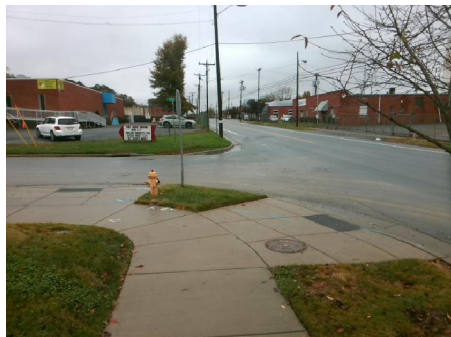
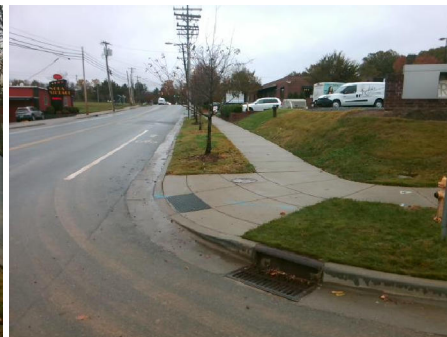
**Not Found, R304.5.3, R304.2.2-Perp,  
R304.3.2-Para**

| Compliance | Description | Data | Compliance | Description | Data |
|---|---|---|---|---|---|
| Yes | Ramp Width (in) | 48.0 | No | Ramp XSlope (%) | 4.1 |
| No | Landing Slope (%) | 3.5 | Yes | DWS Length (in) | 24.5 |
| Yes | Gutter Lip Ht (in) | 0.0 | No | Gutter X Slope (%) | 4.0 |

**Remove & Replace Entire Ramp.  
Remove & Replace Gutter.**

Total Cost: \$ 2600.00
