Intersection ID: 48643	Main Street: SOCATA_WY	Cross Street: BROCK_RN	Location:	N
ADA ID: 0BD306CAB27E	Ramp Type: Perp	Initial Pass/Fail: Pass	Overall Compliance: No	Severity Score: 5

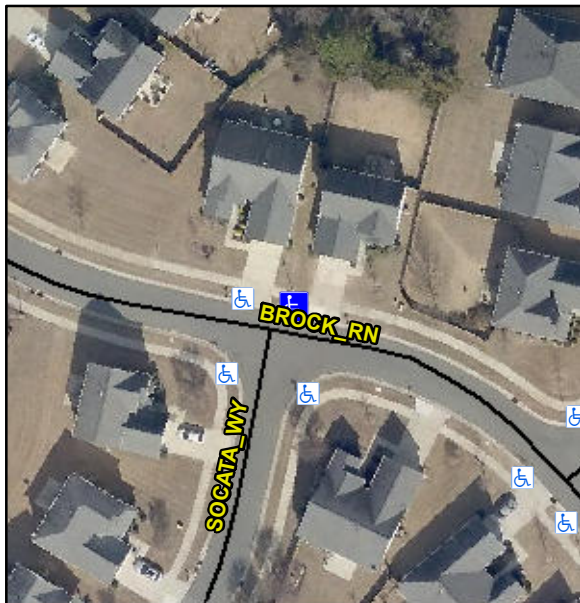
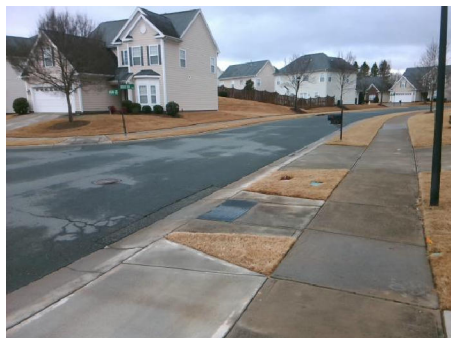
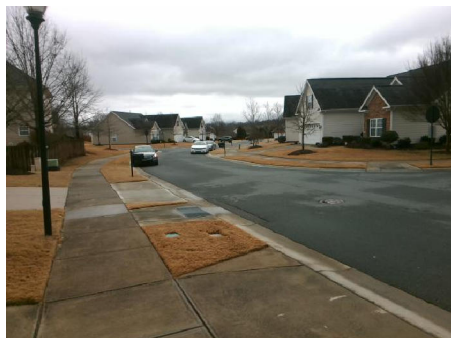
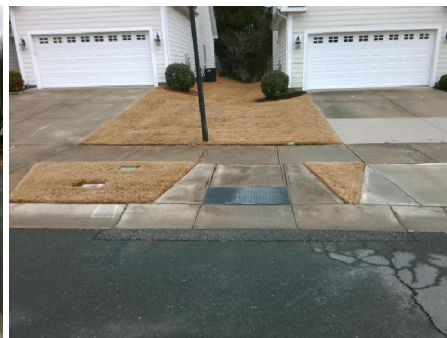
Possible Solutions:		Compliance	Description	Data	Compliance	Description	Data
	Remove & Replace Entire Ramp. Remove & Replace Gutter.		N/A	Ramp Length (in)	72.0	Yes	Ramp Slope (%)	5.5
			Yes	Ramp Width (in)	48.0	Yes	Ramp XSlope (%)	2.0
			N/A	Flare Type LT	Sloped	N/A	Flare Type RT	N/A
			N/A	Flare Slope LT (%)	3.4	N/A	Flare Slope RT (%)	0.1
			N/A	Flare Traversable LT?	No	N/A	Flare Traversable RT?	No
			Yes	Landing Length (in)	59.0	Yes	DWS Provided?	Yes
	Surveyor Notes:  N/A		Yes	Landing Width (in)	60.0	Yes	DWS Contrast?	Yes
			Yes	Landing Slope (%)	0.1	Yes	DWS Length (in)	25.5
			Yes	Landing X Slope (%)	1.9	Yes	DWS Full Width?	Yes
N/A			Landing Curb? (Y/N)	No	Yes	DWS Offset (in)	0.0	
N/A			Shared Landing?	No				
Yes			Gutter Ponding?	No	No	Gutter Slope (%)	7.7	
PROW/ADA:  Not Found, R304.5.4		Yes	Gutter Lip Ht (in)	0.0	Yes	Gutter X Slope (%)	1.6

N/A	Painted X Walk1?	No	N/A	Painted X Walk2?	N/A	
			X Walk 1 Direction	To S		X Walk 2 Direction	N/A	
		N/A	X Walk 1 Width (in)	N/A	N/A	X Walk 2 Width (in)	N/A	
			X Walk 1 Slope (%)	6.1		X Walk 2 Slope (%)	N/A	
			X Walk 1 X Slope (%)	0.1		X Walk 2 X Slope (%)	N/A	
		N/A	Ramp inside XWalk1?	N/A	N/A	Ramp inside XWalk2?	N/A	
			Road Slope (%)	N/A	N/A	Clear Space?	Yes	
			Road X Slope (%)	N/A	N/A	Clear Space to XWalk (in)	N/A	
		Yes	Any Obstructions?	No	Yes	Storm Grate/Utility Hazard?	No	
Total Cost: \$ 2600.00			Obstruction Type			Storm Grate/Utility Type		
				N/A		N/A		
					Yes	Surface Condition? (G/P)	Good
