# Access Compliance Report

## Public Rights-of-Way

### (Curb Ramps)

Intersection ID: 47968	Main Street: MESA_VERDE_RD	Cross Street: KYRENE_RD	Location: SW
ADA ID: 0BDC38AF1D75	Ramp Type: PerpDiag	Initial Pass/Fail: Fail	Overall Compliance: No
Severity Score: 8.75			
Codes/Mitigation Info/Possible Solution		Field Measurements/Component Compliance

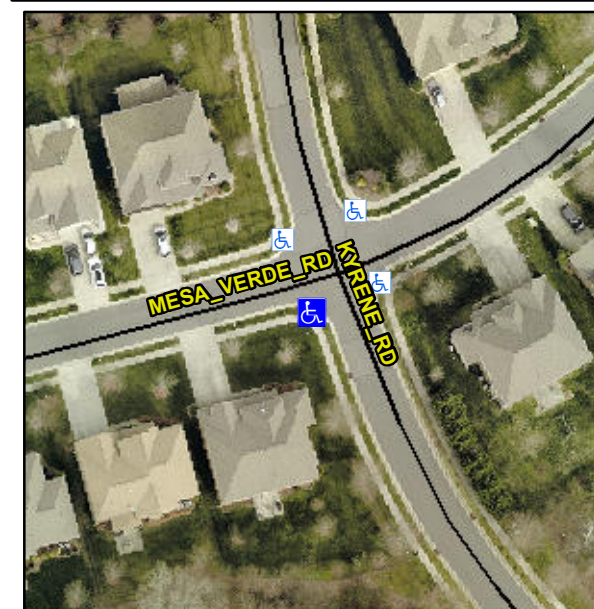
Compliance	Description	Data	Compliance	Description	Data
N/A	Ramp Length (in)	49.0	Yes	Ramp Slope (%)	6.8
No	Ramp Width (in)	46.5	Yes	Ramp XSlope (%)	0.5
N/A	Flare Type LT	N/A	N/A	Flare Type RT	N/A
N/A	Flare Slope LT (%)	N/A	N/A	Flare Slope RT (%)	N/A
N/A	Flare Traversable LT?	N/A	N/A	Flare Traversable RT?	N/A
N/A	Landing Length (in)	N/A	N/A	DWS Provided?	N/A
N/A	Landing Width (in)	N/A	N/A	DWS Contrast?	N/A
N/A	Landing Slope (%)	N/A	N/A	DWS Length (in)	N/A
N/A	Landing X Slope (%)	N/A	N/A	DWS Full Width?	N/A
N/A	Landing Curb? (Y/N)	N/A	N/A	DWS Offset (in)	N/A
N/A	Shared Landing?	N/A			
N/A	Gutter Ponding?	N/A	N/A	Gutter Slope (%)	N/A
N/A	Gutter Lip Ht (in)	N/A	N/A	Gutter X Slope (%)	N/A
N/A	Painted X Walk1?	No	N/A	Painted X Walk2?	No
	X Walk 1 Direction	To E		X Walk 2 Direction	To N
N/A	X Walk 1 Width (in)	N/A	N/A	X Walk 2 Width (in)	N/A
	X Walk 1 Slope (%)	1.1		X Walk 2 Slope (%)	1.3
	X Walk 1 X Slope (%)	1.6		X Walk 2 X Slope (%)	1.2

N/A	Ramp inside XWalk1?	N/A	N/A	Ramp inside XWalk2?	N/A
	Road Slope (%)	1.8	N/A	Clear Space?	N/A
	Road X Slope (%)	1.3	N/A	Clear Space to XWalk (in)	N/A
N/A	Any Obstructions?	N/A	N/A	Storm Grate/Utility Hazard?	N/A
	Obstruction Type			Storm Grate/Utility Type	
		N/A			N/A
			Yes	Surface Condition? (G/P)	Good

Possible Solutions:

**Remove & Replace Curb Ramp With Two New Directional Ramps or Equivalent.**

**R304.5.1**
