# Access Compliance Report

## Public Rights-of-Way

Intersection ID: 45983	Main Street: MASON_MILL_PL	Cross Street: WOODBOURNE_LN	Location: S
ADA ID: 0BF233E5471C	Ramp Type: Perp	Initial Pass/Fail: Fail	Overall Compliance: No
		Severity Score: 25

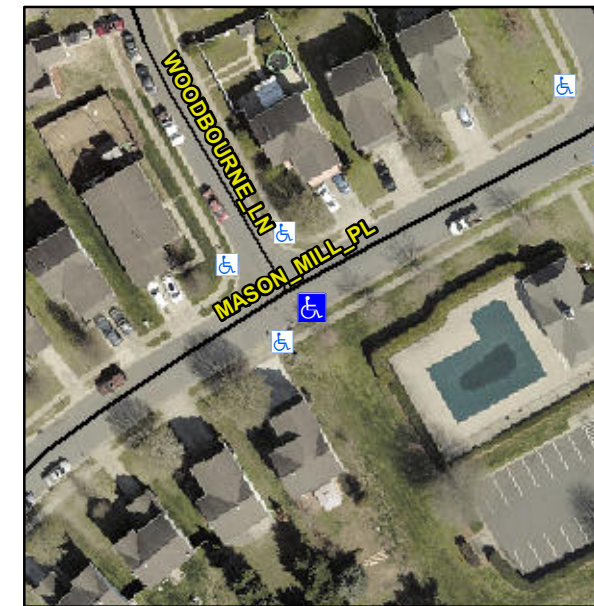
**Not Found, R304.5.3**

Compliance	Description	Data	Compliance	Description	Data
N/A	Ramp Length (in)	47.0	Yes	Ramp Slope (%)	7.3
Yes	Ramp Width (in)	48.0	No	Ramp XSlope (%)	8.8
N/A	Flare Type LT	N/A	N/A	Flare Type RT	N/A
N/A	Flare Slope LT (%)	N/A	N/A	Flare Slope RT (%)	N/A
N/A	Flare Traversable LT?	N/A	N/A	Flare Traversable RT?	N/A
N/A	Landing Length (in)	N/A	N/A	DWS Provided?	N/A
N/A	Landing Width (in)	N/A	N/A	DWS Contrast?	N/A
N/A	Landing Slope (%)	N/A	N/A	DWS Length (in)	N/A
N/A	Landing X Slope (%)	N/A	N/A	DWS Full Width?	N/A
N/A	Landing Curb? (Y/N)	N/A	N/A	DWS Offset (in)	N/A
N/A	Shared Landing?	N/A			
N/A	Gutter Ponding?	N/A	N/A	Gutter Slope (%)	N/A
N/A	Gutter Lip Ht (in)	N/A	N/A	Gutter X Slope (%)	N/A
N/A	Painted X Walk1?	No	N/A	Painted X Walk2?	N/A
	X Walk 1 Direction	To N		X Walk 2 Direction	N/A
N/A	X Walk 1 Width (in)	N/A	N/A	X Walk 2 Width (in)	N/A
	X Walk 1 Slope (%)	2.3		X Walk 2 Slope (%)	N/A
	X Walk 1 X Slope (%)	3.6		X Walk 2 X Slope (%)	N/A

**Remove & Replace Entire Ramp.**
