# Access Compliance Report

## Public Rights-of-Way

### (Curb Ramps)

Intersection ID: 24028	Main Street: EDENBRIDGE_LN	Cross Street: REA_RD	Location: SE
ADA ID: 0BF675B6E608	Ramp Type: PerpDiag	Initial Pass/Fail: Fail	Overall Compliance: No
Codes/Mitigation Info/Possible Solution		Field Measurements/Component Compliance

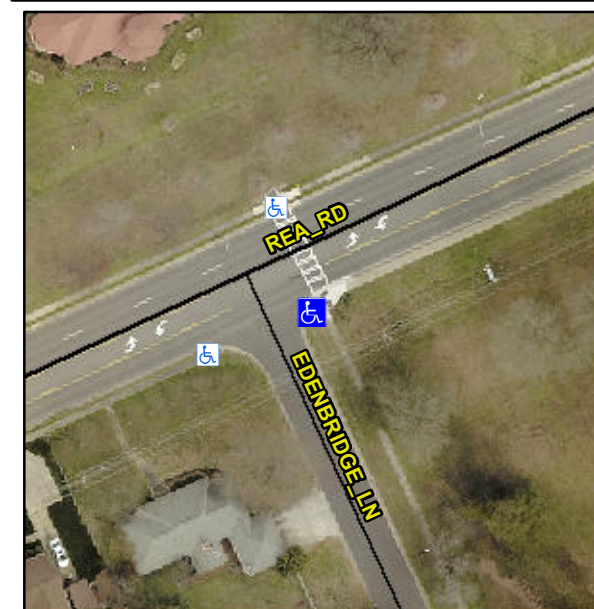
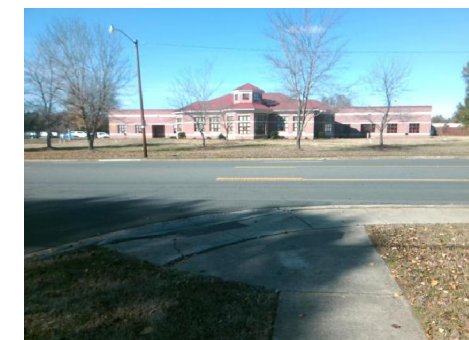
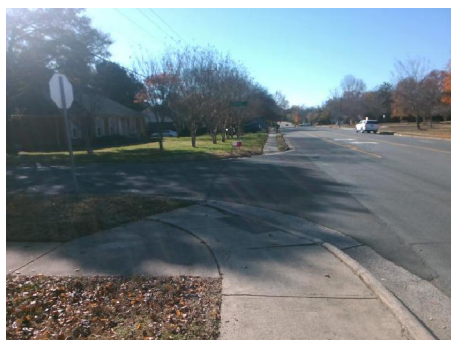
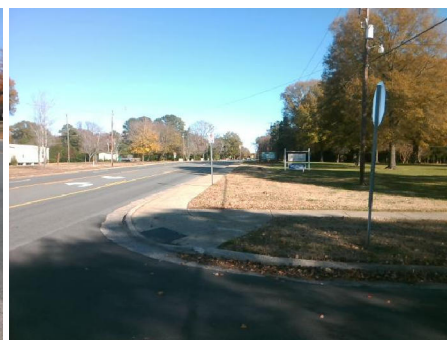
**R304.2.2, R304.5.3**

Compliance	Description	Data	Compliance	Description	Data
N/A	Ramp Length (in)	60.5	No	Ramp Slope (%)	10.2
Yes	Ramp Width (in)	48.0	No	Ramp XSlope (%)	4.1
N/A	Flare Type LT	N/A	N/A	Flare Type RT	N/A
N/A	Flare Slope LT (%)	N/A	N/A	Flare Slope RT (%)	N/A
N/A	Flare Traversable LT?	N/A	N/A	Flare Traversable RT?	N/A
N/A	Landing Length (in)	N/A	N/A	DWS Provided?	N/A
N/A	Landing Width (in)	N/A	N/A	DWS Contrast?	N/A
N/A	Landing Slope (%)	N/A	N/A	DWS Length (in)	N/A
N/A	Landing X Slope (%)	N/A	N/A	DWS Full Width?	N/A
N/A	Landing Curb? (Y/N)	N/A	N/A	DWS Offset (in)	N/A
N/A	Shared Landing?	N/A			
N/A	Gutter Ponding?	N/A	N/A	Gutter Slope (%)	N/A
N/A	Gutter Lip Ht (in)	N/A	N/A	Gutter X Slope (%)	N/A
N/A	Painted X Walk1?	No	N/A	Painted X Walk2?	No
	X Walk 1 Direction	To NW		X Walk 2 Direction	To SW
N/A	X Walk 1 Width (in)	N/A	N/A	X Walk 2 Width (in)	N/A
	X Walk 1 Slope (%)	5.1		X Walk 2 Slope (%)	0.1
	X Walk 1 X Slope (%)	0.9		X Walk 2 X Slope (%)	3.9

N/A	Ramp inside XWalk1?	N/A	N/A	Ramp inside XWalk2?	N/A
	Road Slope (%)	4.1	N/A	Clear Space?	N/A
	Road X Slope (%)	2.9	N/A	Clear Space to XWalk (in)	N/A
N/A	Any Obstructions?	N/A	N/A	Storm Grate/Utility Hazard?	N/A
	Obstruction Type			Storm Grate/Utility Type	
		N/A			N/A
			Yes	Surface Condition? (G/P)	Good

**Remove & Replace Curb Ramp With Two New Directional Ramps or Equivalent.**

Total Cost: \$ 3200.00
