# Access Compliance Report

## Public Rights-of-Way

### (Curb Ramps)

Intersection ID: 43762	Main Street: HELENS_LN	Cross Street: ZIEGLER_LN	Location: SW
ADA ID: 0BFD4DF45D35	Ramp Type: Perp	Initial Pass/Fail: Fail	Overall Compliance: No
		Severity Score: 10

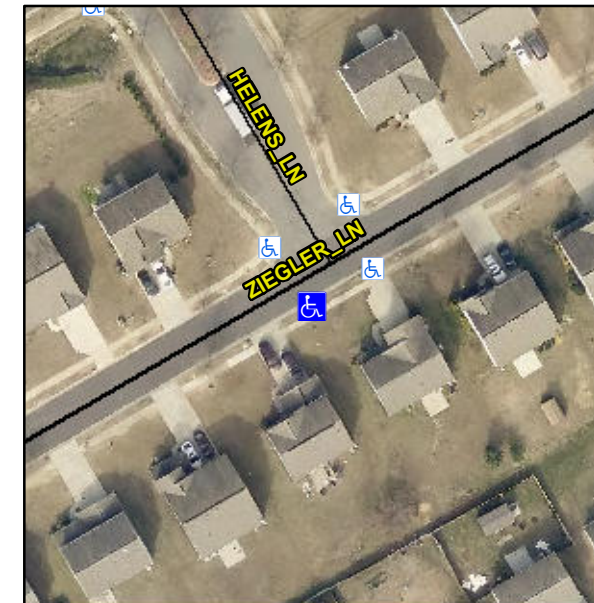
**Not Found, R304.5.1**

Compliance	Description	Data	Compliance	Description	Data
N/A	Ramp Length (in)	48.0	Yes	Ramp Slope (%)	7.5
No	Ramp Width (in)	47.0	Yes	Ramp XSlope (%)	2.8
N/A	Flare Type LT	N/A	N/A	Flare Type RT	N/A
N/A	Flare Slope LT (%)	N/A	N/A	Flare Slope RT (%)	N/A
N/A	Flare Traversable LT?	N/A	N/A	Flare Traversable RT?	N/A
N/A	Landing Length (in)	N/A	N/A	DWS Provided?	N/A
N/A	Landing Width (in)	N/A	N/A	DWS Contrast?	N/A
N/A	Landing Slope (%)	N/A	N/A	DWS Length (in)	N/A
N/A	Landing X Slope (%)	N/A	N/A	DWS Full Width?	N/A
N/A	Landing Curb? (Y/N)	N/A	N/A	DWS Offset (in)	N/A
N/A	Shared Landing?	N/A			
N/A	Gutter Ponding?	N/A	N/A	Gutter Slope (%)	N/A
N/A	Gutter Lip Ht (in)	N/A	N/A	Gutter X Slope (%)	N/A
N/A	Painted X Walk1?	No	N/A	Painted X Walk2?	N/A
	X Walk 1 Direction	To N		X Walk 2 Direction	N/A
N/A	X Walk 1 Width (in)	N/A	N/A	X Walk 2 Width (in)	N/A
	X Walk 1 Slope (%)	4.6		X Walk 2 Slope (%)	N/A
	X Walk 1 X Slope (%)	2.9		X Walk 2 X Slope (%)	N/A

N/A	Ramp inside XWalk1?	N/A	N/A	Ramp inside XWalk2?	N/A
	Road Slope (%)	N/A	N/A	Clear Space?	N/A
	Road X Slope (%)	N/A	N/A	Clear Space to XWalk (in)	N/A
N/A	Any Obstructions?	N/A	N/A	Storm Grate/Utility Hazard?	N/A
	Obstruction Type			Storm Grate/Utility Type	
		N/A			N/A
			Yes	Surface Condition? (G/P)	Good

**Remove & Replace Entire Ramp.**
