Access Compliance Report

Public Rights-of-Way

(Curb Ramps)

| Intersection ID: 12942 | Main Street: HICKORY GROVE RD | Cross Street: MCALPINE LN | Location: SW |

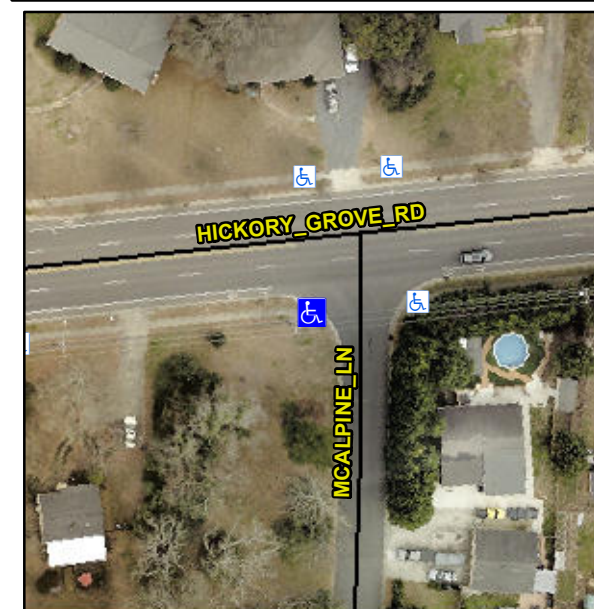
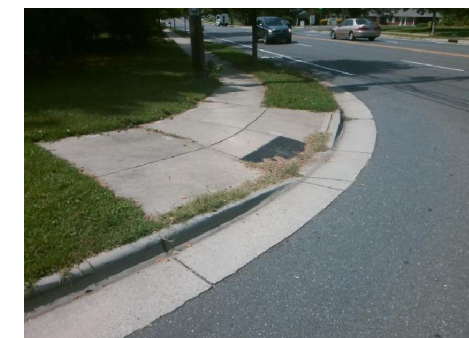
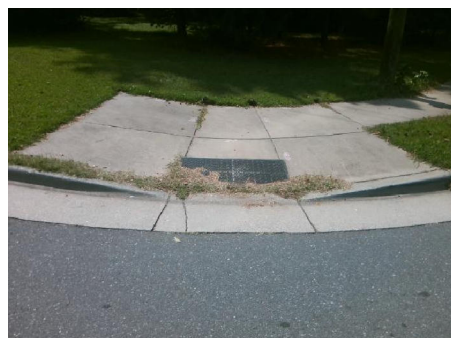
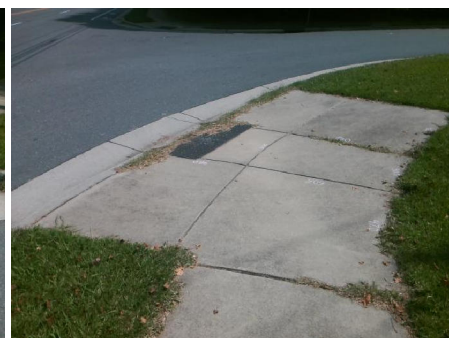
| ADA ID: 0C0329A85857 | Ramp Type: PerpDiag | Initial Pass/Fail: Fail | Overall Compliance: No |
| Severity Score: 22.5 | | | |

Not Found, R304.5.1, R304.2.2, R304.5.3

| Compliance | Description | Data | Compliance | Description | Data |
|---|---|---|---|---|---|
| N/A | Ramp Length (in) | 48.0 | No | Ramp Slope (%) | 10.0 |
| No | Ramp Width (in) | 39.5 | No | Ramp XSlope (%) | 3.4 |

Remove & Replace Curb Ramp With Two New Directional Ramps or Equivalent.
