Access Compliance Report

Public Rights-of-Way

(Curb Ramps)

Intersection ID: 26999	Main Street: SETON_HOUSE_LN	Cross Street: SHEPHERDLEAS_LN	Location: NE
ADA ID: 0C0A9C61FF11	Ramp Type: PerpDiag	Initial Pass/Fail: Fail	Overall Compliance: No
Severity Score: 8.75			
Codes/Mitigation Info/Possible Solution		Field Measurements/Component Compliance

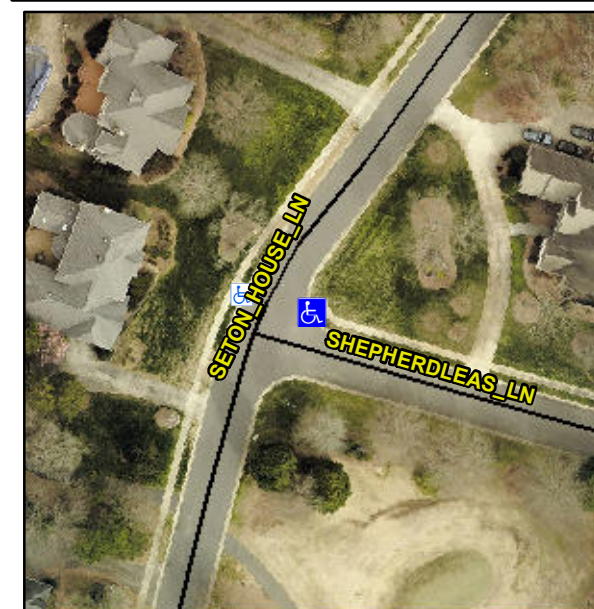
Compliance	Description	Data	Compliance	Description	Data
N/A	Ramp Length (in)	49.0	Yes	Ramp Slope (%)	6.4
No	Ramp Width (in)	36.5	Yes	Ramp XSlope (%)	0.7
N/A	Flare Type LT	N/A	N/A	Flare Type RT	N/A
N/A	Flare Slope LT (%)	N/A	N/A	Flare Slope RT (%)	N/A
N/A	Flare Traversable LT?	N/A	N/A	Flare Traversable RT?	N/A
N/A	Landing Length (in)	N/A	N/A	DWS Provided?	N/A
N/A	Landing Width (in)	N/A	N/A	DWS Contrast?	N/A
N/A	Landing Slope (%)	N/A	N/A	DWS Length (in)	N/A
N/A	Landing X Slope (%)	N/A	N/A	DWS Full Width?	N/A
N/A	Landing Curb? (Y/N)	N/A	N/A	DWS Offset (in)	N/A
N/A	Shared Landing?	N/A			
N/A	Gutter Ponding?	N/A	N/A	Gutter Slope (%)	N/A
N/A	Gutter Lip Ht (in)	N/A	N/A	Gutter X Slope (%)	N/A
N/A	Painted X Walk1?	No	N/A	Painted X Walk2?	No
	X Walk 1 Direction	To W		X Walk 2 Direction	To S
N/A	X Walk 1 Width (in)	N/A	N/A	X Walk 2 Width (in)	N/A
	X Walk 1 Slope (%)	7.8		X Walk 2 Slope (%)	5.5
	X Walk 1 X Slope (%)	2.2		X Walk 2 X Slope (%)	6.7

N/A	Ramp inside XWalk1?	N/A	N/A	Ramp inside XWalk2?	N/A
	Road Slope (%)	0.8	N/A	Clear Space?	N/A
	Road X Slope (%)	9.1	N/A	Clear Space to XWalk (in)	N/A
N/A	Any Obstructions?	N/A	N/A	Storm Grate/Utility Hazard?	N/A
	Obstruction Type			Storm Grate/Utility Type	
		N/A			N/A
		Yes		Surface Condition? (G/P)	Good

Possible Solutions:

Remove & Replace Curb Ramp With Two New Directional Ramps or Equivalent.
