Access Compliance Report

Public Rights-of-Way

(Curb Ramps)

Intersection ID: 10040728	Main Street: N_SYCAMORE_ST	Cross Street: N/A	Location: NW
ADA ID: 0C0B4E5EF89D	Ramp Type: Perp	Initial Pass/Fail: Fail	Overall Compliance: No
			Severity Score: 1.25

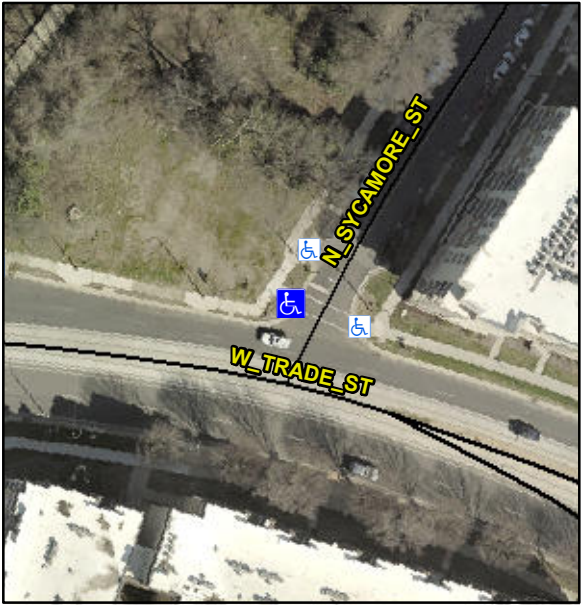
<p>Street 1 Name: N SYCAMORE ST</p> <p>Stop Condition-Street 2: StopSign</p> <p>Street 2 Name: N/A</p> <p>Stop Condition-Street 1: N/A</p>	Possible Solutions:	Compliance	Description	Data	Compliance	Description	Data
	Remove & Replace Entire Ramp.	N/A	Ramp Length (in)	120.0	Yes	Ramp Slope (%)	5.2
		Yes	Ramp Width (in)	58.0	No	Ramp XSlope (%)	2.1
		N/A	Flare Type LT	N/A	N/A	Flare Type RT	N/A
		N/A	Flare Slope LT (%)	N/A	N/A	Flare Slope RT (%)	N/A
		N/A	Flare Traversable LT?	N/A	N/A	Flare Traversable RT?	N/A
		N/A	Landing Length (in)	N/A	N/A	DWS Provided?	N/A
		N/A	Landing Width (in)	N/A	N/A	DWS Contrast?	N/A
		N/A	Landing Slope (%)	N/A	N/A	DWS Length (in)	N/A
		N/A	Landing X Slope (%)	N/A	N/A	DWS Full Width?	N/A
		N/A	Landing Curb? (Y/N)	N/A	N/A	DWS Offset (in)	N/A
		N/A	Shared Landing?	N/A			
		N/A	Gutter Ponding?	N/A	N/A	Gutter Slope (%)	N/A

N/A	Gutter Lip Ht (in)	N/A	N/A	Gutter X Slope (%)	N/A
		N/A	Painted X Walk1?	Yes	N/A	Painted X Walk2?	N/A
			X Walk 1 Direction	To SE		X Walk 2 Direction	N/A
		N/A	X Walk 1 Width (in)	114.0	N/A	X Walk 2 Width (in)	N/A
			X Walk 1 Slope (%)	5.5		X Walk 2 Slope (%)	N/A
			X Walk 1 X Slope (%)	0.5		X Walk 2 X Slope (%)	N/A
		N/A	Ramp inside XWalk1?	Yes	N/A	Ramp inside XWalk2?	N/A
<p>Surveyor Notes:</p> <p>N/A</p> <p>PROW/ADA:</p> <p>R304.5.3</p> <p>Total Cost: \$ 1850.00</p>	Road Slope (%)	N/A	N/A	N/A	N/A	Clear Space?	N/A
	Road X Slope (%)	N/A	N/A	N/A	N/A	Clear Space to XWalk (in)	N/A
	Any Obstructions?	N/A	N/A	N/A	N/A	Storm Grate/Utility Hazard?	N/A
	Obstruction Type					Storm Grate/Utility Type	
					N/A		N/A
					Yes	Surface Condition? (G/P)	Good
