# Access Compliance Report

## Public Rights-of-Way

### (Curb Ramps)

Intersection ID: 26090	Main Street: PROVIDENCE_RD	Cross Street: LAKESIDE_DR	Location: SE
ADA ID: 0C0EAB9AD34B	Ramp Type: Perp	Initial Pass/Fail: Fail	Overall Compliance: No
Severity Score: 8.75			
Codes/Mitigation Info/Possible Solution		Field Measurements/Component Compliance

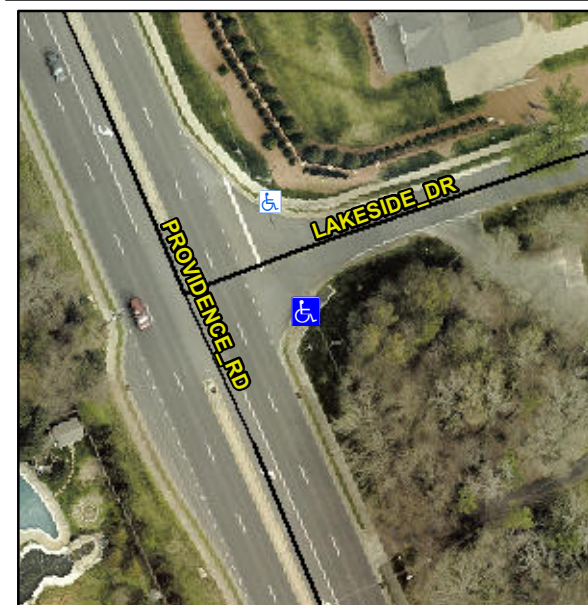
**Not Found, R304.5.1**

Compliance	Description	Data	Compliance	Description	Data
N/A	Ramp Length (in)	73.0	Yes	Ramp Slope (%)	5.6
No	Ramp Width (in)	47.5	Yes	Ramp XSlope (%)	0.3
N/A	Flare Type LT	N/A	N/A	Flare Type RT	N/A
N/A	Flare Slope LT (%)	N/A	N/A	Flare Slope RT (%)	N/A
N/A	Flare Traversable LT?	N/A	N/A	Flare Traversable RT?	N/A
N/A	Landing Length (in)	N/A	N/A	DWS Provided?	N/A
N/A	Landing Width (in)	N/A	N/A	DWS Contrast?	N/A
N/A	Landing Slope (%)	N/A	N/A	DWS Length (in)	N/A
N/A	Landing X Slope (%)	N/A	N/A	DWS Full Width?	N/A
N/A	Landing Curb? (Y/N)	N/A	N/A	DWS Offset (in)	N/A
N/A	Shared Landing?	N/A			
N/A	Gutter Ponding?	N/A	N/A	Gutter Slope (%)	N/A
N/A	Gutter Lip Ht (in)	N/A	N/A	Gutter X Slope (%)	N/A
N/A	Painted X Walk1?	No	N/A	Painted X Walk2?	N/A
	X Walk 1 Direction	To N		X Walk 2 Direction	N/A
N/A	X Walk 1 Width (in)	N/A	N/A	X Walk 2 Width (in)	N/A
	X Walk 1 Slope (%)	3.0		X Walk 2 Slope (%)	N/A
	X Walk 1 X Slope (%)	0.8		X Walk 2 X Slope (%)	N/A

N/A	Ramp inside XWalk1?	N/A	N/A	Ramp inside XWalk2?	N/A
	Road Slope (%)	N/A	N/A	Clear Space?	N/A
	Road X Slope (%)	N/A	N/A	Clear Space to XWalk (in)	N/A
N/A	Any Obstructions?	N/A	N/A	Storm Grate/Utility Hazard?	N/A
	Obstruction Type			Storm Grate/Utility Type	
		N/A			N/A
			Yes	Surface Condition? (G/P)	Good

**Remove & Replace Entire Ramp.**

Total Cost: \$ 1850.00
