# Access Compliance Report

## Public Rights-of-Way

### (Curb Ramps)

Intersection ID: 54779	Main Street: SHARON AMITY RD	Cross Street: CHARLESTON DR	Location: NE
ADA ID: 0C1205E72F7F	Ramp Type: Perp	Initial Pass/Fail: Pass	Overall Compliance: Yes
Codes/Mitigation Info/Possible Solution		Field Measurements/Component Compliance	
Severity Score: 0.25

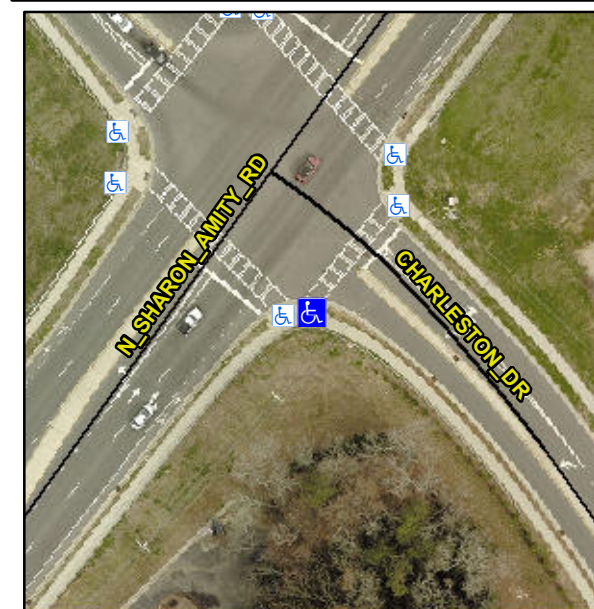
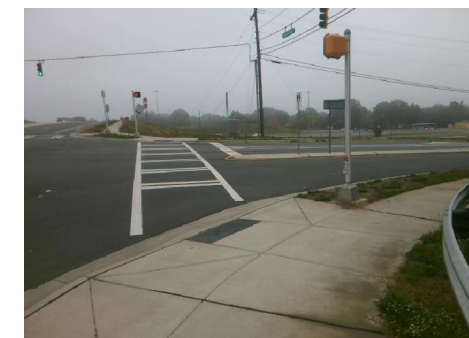
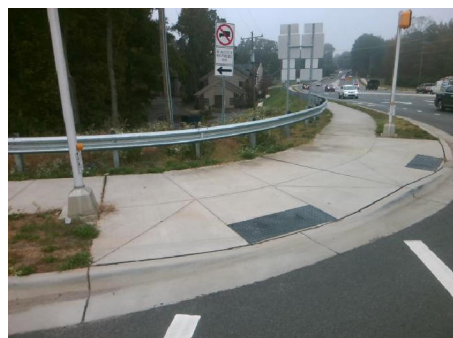
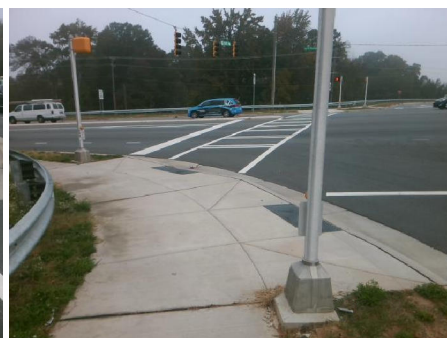
Compliance	Description	Data	Compliance	Description	Data
N/A	Ramp Length (in)	66.0	Yes	Ramp Slope (%)	5.2
Yes	Ramp Width (in)	58.5	Yes	Ramp XSlope (%)	2.3
N/A	Flare Type LT	Sloped	N/A	Flare Type RT	N/A
N/A	Flare Slope LT (%)	6.4	Yes	Flare Slope RT (%)	2.6
N/A	Flare Traversable LT?	Yes	N/A	Flare Traversable RT?	Yes
Yes	Landing Length (in)	71.5	Yes	DWS Provided?	Yes
Yes	Landing Width (in)	60.0	Yes	DWS Contrast?	Yes
Yes	Landing Slope (%)	1.9	Yes	DWS Length (in)	24.0
Yes	Landing X Slope (%)	1.6	Yes	DWS Full Width?	Yes
N/A	Landing Curb? (Y/N)	No	Yes	DWS Offset (in)	1.0
N/A	Shared Landing?	No			
Yes	Gutter Ponding?	No	Yes	Gutter Slope (%)	1.8
Yes	Gutter Lip Ht (in)	0.0	Yes	Gutter X Slope (%)	0.9
N/A	Painted X Walk1?	Yes	N/A	Painted X Walk2?	N/A
	X Walk 1 Direction	To NE		X Walk 2 Direction	N/A
N/A	X Walk 1 Width (in)	88.0	N/A	X Walk 2 Width (in)	N/A
	X Walk 1 Slope (%)	8.6		X Walk 2 Slope (%)	N/A
	X Walk 1 X Slope (%)	2.5		X Walk 2 X Slope (%)	N/A

Yes	Ramp inside XWalk1?	Yes	N/A	Ramp inside XWalk2?	N/A
	Road Slope (%)	N/A	N/A	Clear Space?	Yes
	Road X Slope (%)	N/A	N/A	Clear Space to XWalk (in)	N/A
Yes	Any Obstructions?	No	Yes	Storm Grate/Utility Hazard?	No
	Obstruction Type			Storm Grate/Utility Type	
		N/A			N/A
			Yes	Surface Condition? (G/P)	Good
