Access Compliance Report

Public Rights-of-Way

(Curb Ramps)

| Intersection ID: 43521 | Main Street: MORNING_BREEZE_LN | Cross Street: MISTRAL_WY | Location: W |

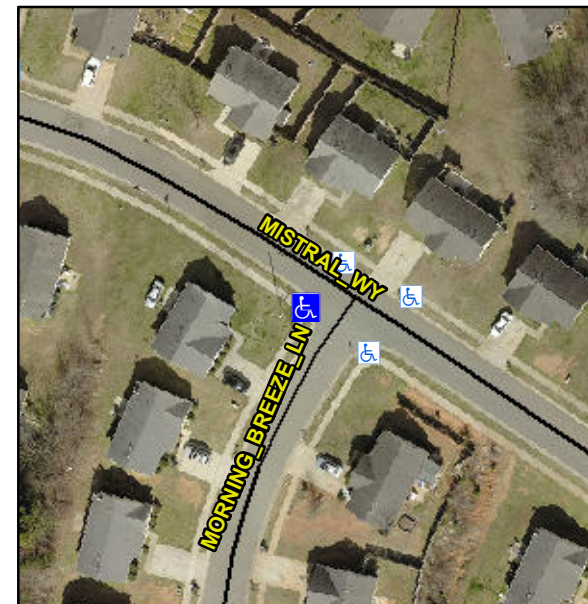
| ADA ID: 0C255770C71E | Ramp Type: PerpDiag | Initial Pass/Fail: Fail | Overall Compliance: No |
| Severity Score: 21.25 | | | |

R304.5.1, R304.5.3

| Compliance | Description | Data | Compliance | Description | Data |
|---|---|---|---|---|---|
| No | Ramp Width (in) | 46.5 | No | Ramp XSlope (%) | 5.7 |

Remove & Replace Curb Ramp With Two New Directional Ramps or Equivalent.

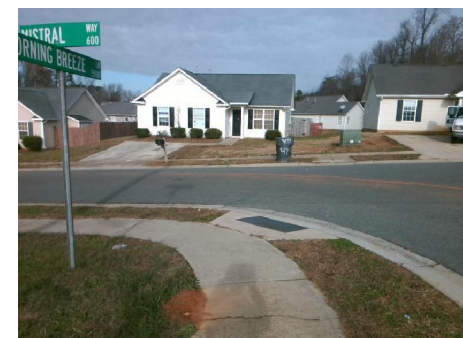
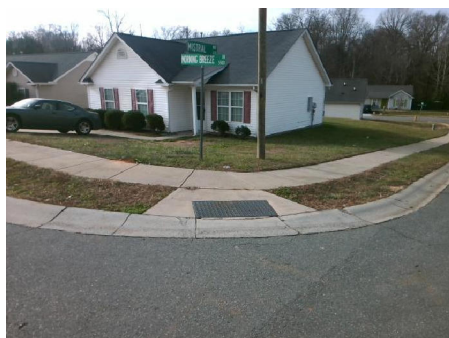
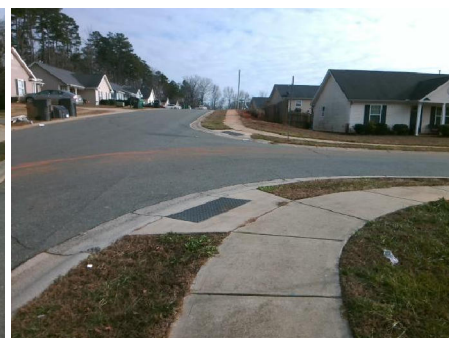
| Compliance | Description | Data | Compliance | Description | Data |
|---|---|---|---|---|---|
| N/A | Ramp Length (in) | 46.5 | Yes | Ramp Slope (%) | 6.2 |
| | | | Yes | Surface Condition? (G/P) | Good |
