Access Compliance Report

Public Rights-of-Way

(Curb Ramps)

Intersection ID: 21312	Main Street: E_ARROWOOD_RD	Cross Street: SOUTH_BV	Location: SE
ADA ID: 0C2568691B18	Ramp Type: Perp	Initial Pass/Fail: Fail	Overall Compliance: No
Severity Score: 21.25			
Codes/Mitigation Info/Possible Solution		Field Measurements/Component Compliance

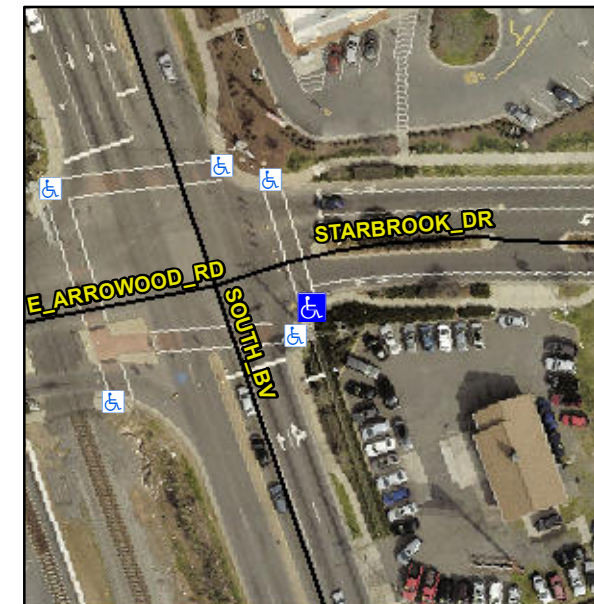
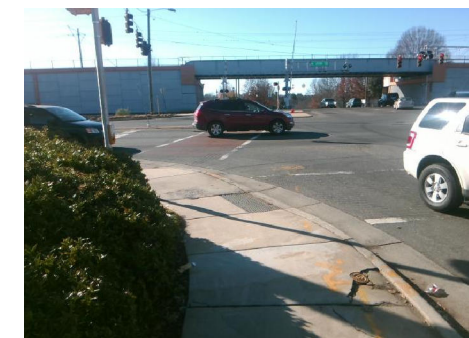
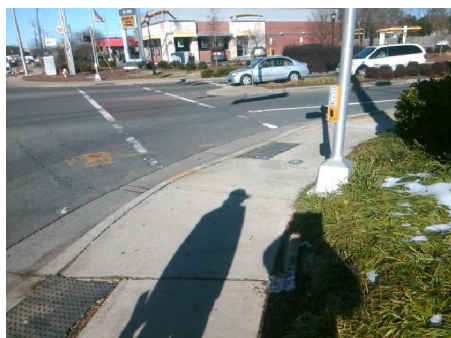
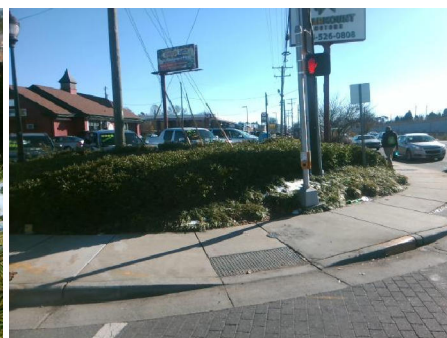
Not Found, R304.5.1, R304.2.2

Compliance	Description	Data	Compliance	Description	Data
N/A	Ramp Length (in)	71.0	No	Ramp Slope (%)	8.5
No	Ramp Width (in)	45.0	Yes	Ramp XSlope (%)	1.2
N/A	Flare Type LT	N/A	N/A	Flare Type RT	N/A
N/A	Flare Slope LT (%)	N/A	N/A	Flare Slope RT (%)	N/A
N/A	Flare Traversable LT?	N/A	N/A	Flare Traversable RT?	N/A
N/A	Landing Length (in)	N/A	N/A	DWS Provided?	N/A
N/A	Landing Width (in)	N/A	N/A	DWS Contrast?	N/A
N/A	Landing Slope (%)	N/A	N/A	DWS Length (in)	N/A
N/A	Landing X Slope (%)	N/A	N/A	DWS Full Width?	N/A
N/A	Landing Curb? (Y/N)	N/A	N/A	DWS Offset (in)	N/A
N/A	Shared Landing?	N/A			
N/A	Gutter Ponding?	N/A	N/A	Gutter Slope (%)	N/A
N/A	Gutter Lip Ht (in)	N/A	N/A	Gutter X Slope (%)	N/A
N/A	Painted X Walk1?	Yes	N/A	Painted X Walk2?	N/A
	X Walk 1 Direction	To N		X Walk 2 Direction	N/A
N/A	X Walk 1 Width (in)	121.0	N/A	X Walk 2 Width (in)	N/A
	X Walk 1 Slope (%)	2.4		X Walk 2 Slope (%)	N/A
	X Walk 1 X Slope (%)	1.2		X Walk 2 X Slope (%)	N/A

N/A	Ramp inside XWalk1?	Yes	N/A	Ramp inside XWalk2?	N/A
	Road Slope (%)	N/A	N/A	Clear Space?	N/A
	Road X Slope (%)	N/A	N/A	Clear Space to XWalk (in)	N/A
N/A	Any Obstructions?	N/A	N/A	Storm Grate/Utility Hazard?	N/A
	Obstruction Type			Storm Grate/Utility Type	
		N/A			N/A
			Yes	Surface Condition? (G/P)	Good

Possible Solutions:

Remove & Replace Entire Ramp.
