Good

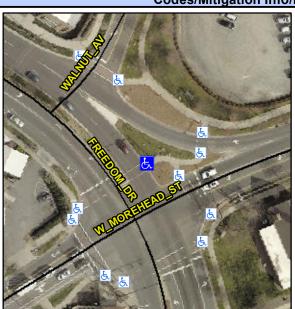
Intersection ID: 12013 Main Street: FREEDOM DR **Cross Street: W MOREHEAD ST** Location: Ε ADA ID: 0C272DC1128C **Overall Compliance: No Severity Score:**

Initial Pass/Fail: Fail

Possible Solutions:	Compli	ance	Description
Remove & Replace Entire Ramp.	N/A	Ram	Length (in)
·	No	Ram	Width (in)
	N/A	Flare	Type LT
	N/A	Flare	Slope LT (%)
	N/A	Flare	Traversable LT
	N/A	Land	ing Length (in)
Surveyor Notes:	N/A	Land	ing Width (in)
N/A	N/A	Land	ing Slope (%)
	N/A	Land	ing X Slope (%
	N/A	Land	ing Curb? (Y/N
	N/A	Share	ed Landing?
PROW/ADA:	N/A	Gutte	er Ponding?
Not Found, R304.5.1	N/A	Gutte	er Lip Ht (in)
	N/A	Paint	ed X Walk1?
		X Wa	lk 1 Direction
	N/A	X Wa	lk 1 Width (in)
		X Wa	lk 1 Slope (%)
		X Wa	lk 1 X Slope (%
	N/A	Ram	o inside XWalk
