Access Compliance Report

Public Rights-of-Way

(Curb Ramps)

Intersection ID: 23363	Main Street: CARNOUSTIE_LN	Cross Street: QUAIL_HOLLOW_RD	Location: S
ADA ID: 0C2C3EC6D9EE	Ramp Type: PerpDiag	Initial Pass/Fail: Fail	Overall Compliance: No
Severity Score: 13.75			
Codes/Mitigation Info/Possible Solution		Field Measurements/Component Compliance

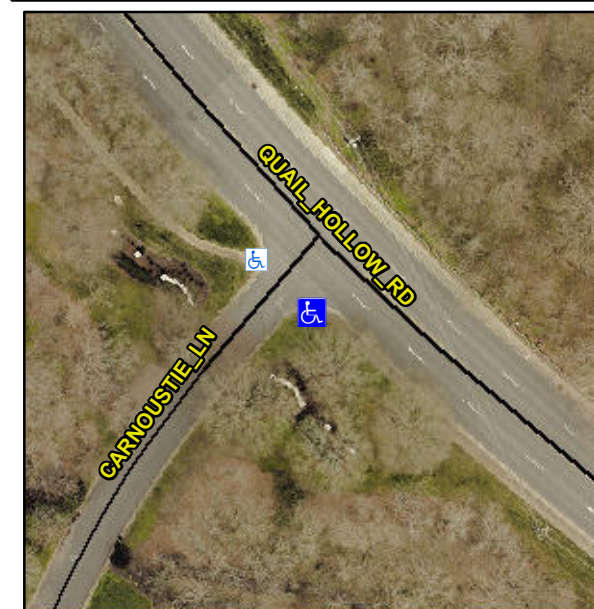
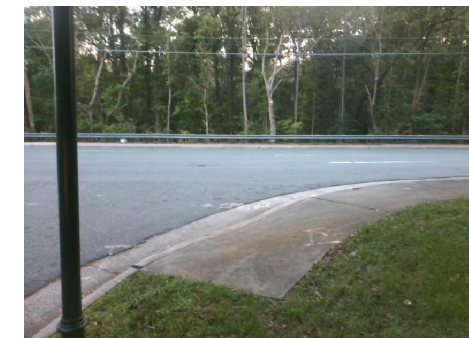
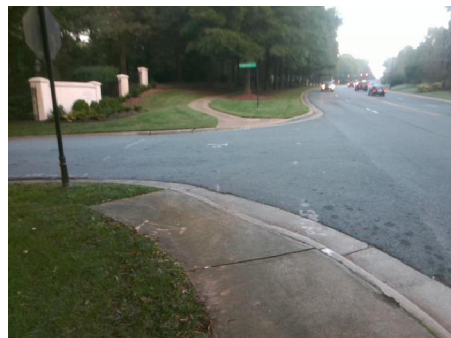
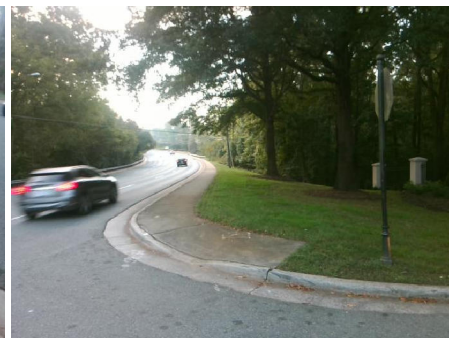
Not Found, R304.2.2, R304.5.3

Compliance	Description	Data	Compliance	Description	Data
N/A	Ramp Length (in)	58.0	No	Ramp Slope (%)	10.2
Yes	Ramp Width (in)	48.0	No	Ramp XSlope (%)	3.8
N/A	Flare Type LT	N/A	N/A	Flare Type RT	N/A
N/A	Flare Slope LT (%)	N/A	N/A	Flare Slope RT (%)	N/A
N/A	Flare Traversable LT?	N/A	N/A	Flare Traversable RT?	N/A
N/A	Landing Length (in)	N/A	N/A	DWS Provided?	N/A
N/A	Landing Width (in)	N/A	N/A	DWS Contrast?	N/A
N/A	Landing Slope (%)	N/A	N/A	DWS Length (in)	N/A
N/A	Landing X Slope (%)	N/A	N/A	DWS Full Width?	N/A
N/A	Landing Curb? (Y/N)	N/A	N/A	DWS Offset (in)	N/A
N/A	Shared Landing?	N/A			
N/A	Gutter Ponding?	N/A	N/A	Gutter Slope (%)	N/A
N/A	Gutter Lip Ht (in)	N/A	N/A	Gutter X Slope (%)	N/A
N/A	Painted X Walk1?	No	N/A	Painted X Walk2?	No
	X Walk 1 Direction	To NE		X Walk 2 Direction	To NW
N/A	X Walk 1 Width (in)	N/A	N/A	X Walk 2 Width (in)	N/A
	X Walk 1 Slope (%)	6.3		X Walk 2 Slope (%)	5.8
	X Walk 1 X Slope (%)	6.4		X Walk 2 X Slope (%)	4.0

N/A	Ramp inside XWalk1?	N/A	N/A	Ramp inside XWalk2?	N/A
	Road Slope (%)	1.1	N/A	Clear Space?	N/A
	Road X Slope (%)	10.6	N/A	Clear Space to XWalk (in)	N/A
N/A	Any Obstructions?	N/A	N/A	Storm Grate/Utility Hazard?	N/A
	Obstruction Type			Storm Grate/Utility Type	
		N/A			N/A
		Yes		Surface Condition? (G/P)	Good

Remove & Replace Curb Ramp With Two New Directional Ramps or Equivalent.
