Access Compliance Report

Public Rights-of-Way

(Curb Ramps)

Intersection ID: 3242	Main Street: MALLARD_PINE_CT	Cross Street: SHELLY_PINES_DR	Location: SW
ADA ID: 0C38EE67EAB0	Ramp Type: Perp	Initial Pass/Fail: Fail	Overall Compliance: No
Severity Score: 37.5			
Codes/Mitigation Info/Possible Solution		Field Measurements/Component Compliance

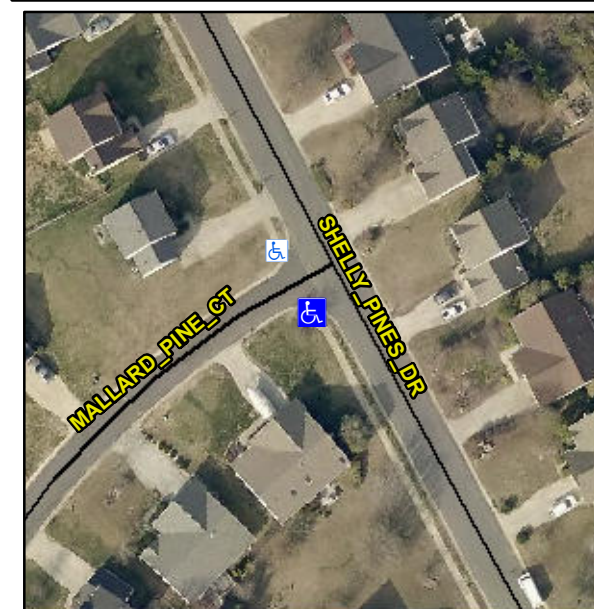
Not Found, R304.2.2, R304.5.3

Compliance	Description	Data	Compliance	Description	Data
N/A	Ramp Length (in)	49.0	No	Ramp Slope (%)	8.6
Yes	Ramp Width (in)	68.0	No	Ramp XSlope (%)	7.6
N/A	Flare Type LT	N/A	N/A	Flare Type RT	N/A
N/A	Flare Slope LT (%)	N/A	N/A	Flare Slope RT (%)	N/A
N/A	Flare Traversable LT?	N/A	N/A	Flare Traversable RT?	N/A
N/A	Landing Length (in)	N/A	N/A	DWS Provided?	N/A
N/A	Landing Width (in)	N/A	N/A	DWS Contrast?	N/A
N/A	Landing Slope (%)	N/A	N/A	DWS Length (in)	N/A
N/A	Landing X Slope (%)	N/A	N/A	DWS Full Width?	N/A
N/A	Landing Curb? (Y/N)	N/A	N/A	DWS Offset (in)	N/A
N/A	Shared Landing?	N/A			
N/A	Gutter Ponding?	N/A	N/A	Gutter Slope (%)	N/A
N/A	Gutter Lip Ht (in)	1.5	N/A	Gutter X Slope (%)	N/A
N/A	Painted X Walk1?	No	N/A	Painted X Walk2?	N/A
	X Walk 1 Direction	To N		X Walk 2 Direction	N/A
N/A	X Walk 1 Width (in)	N/A	N/A	X Walk 2 Width (in)	N/A
	X Walk 1 Slope (%)	3.5		X Walk 2 Slope (%)	N/A
	X Walk 1 X Slope (%)	10.8		X Walk 2 X Slope (%)	N/A

N/A	Ramp inside XWalk1?	N/A	N/A	Ramp inside XWalk2?	N/A
	Road Slope (%)	N/A	N/A	Clear Space?	N/A
	Road X Slope (%)	N/A	N/A	Clear Space to XWalk (in)	N/A
N/A	Any Obstructions?	N/A	N/A	Storm Grate/Utility Hazard?	N/A
	Obstruction Type			Storm Grate/Utility Type	
		N/A			N/A
			Yes	Surface Condition? (G/P)	Good

Possible Solutions:

Remove & Replace Entire Ramp.
