Access Compliance Report

Public Rights-of-Way

(Curb Ramps)

Intersection ID: 9455	Main Street: CAMBRIDGE_COMMONS_DR	Cross Street: SAM_DEE_RD	Location: E
ADA ID: 0C3C45DFC4FE	Ramp Type: BlendTrans1	Initial Pass/Fail: Fail	Overall Compliance: No
Severity Score: 21.25			
Codes/Mitigation Info/Possible Solution		Field Measurements/Component Compliance

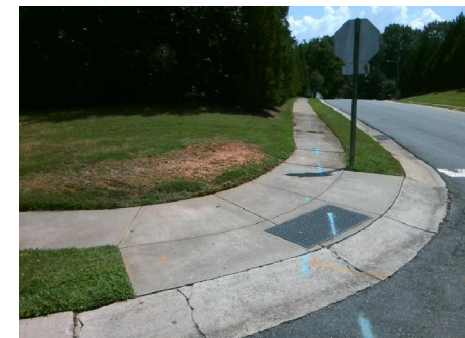
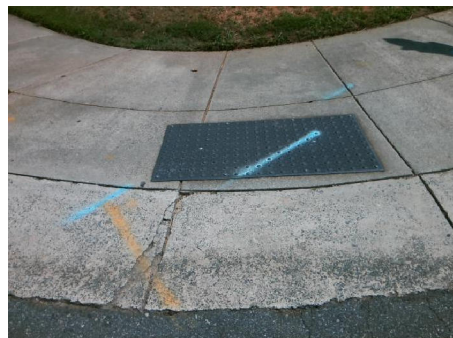
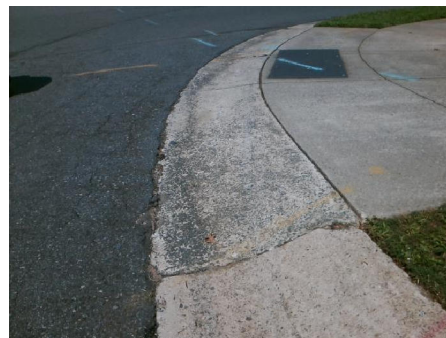
Not Found, R304.5.1, R304.5.3

Compliance	Description	Data	Compliance	Description	Data
N/A	Ramp Length (in)	35.0	Yes	BlendTrans Slope (%)	0.5
No	Ramp Width (in)	41.0	No	BlendTrans XSlope (%)	6.9
N/A	Flare Type LT	N/A	N/A	Flare Type RT	N/A
N/A	Flare Slope LT (%)	N/A	N/A	Flare Slope RT (%)	N/A
N/A	Flare Traversable LT?	N/A	N/A	Flare Traversable RT?	N/A
N/A	Landing Length (in)	N/A	N/A	DWS Provided?	N/A
N/A	Landing Width (in)	N/A	N/A	DWS Contrast?	N/A
N/A	Landing Slope (%)	N/A	N/A	DWS Length (in)	N/A
N/A	Landing X Slope (%)	N/A	N/A	DWS Full Width?	N/A
N/A	Landing Curb? (Y/N)	N/A	N/A	DWS Offset (in)	N/A
N/A	Shared Landing?	N/A			
N/A	Gutter Ponding?	N/A	N/A	Gutter Slope (%)	N/A
N/A	Gutter Lip Ht (in)	N/A	N/A	Gutter X Slope (%)	N/A
N/A	Painted X Walk1?	No	N/A	Painted X Walk2?	N/A
	X Walk 1 Direction	To SW		X Walk 2 Direction	N/A
	X Walk 1 Width (in)	N/A		X Walk 2 Width (in)	N/A
	X Walk 1 Slope (%)	3.8		X Walk 2 Slope (%)	N/A
	X Walk 1 X Slope (%)	4.6		X Walk 2 X Slope (%)	N/A

N/A	Ramp inside XWalk1?	N/A	N/A	Ramp inside XWalk2?	N/A
	Road Slope (%)	4.6		Clear Space?	N/A
	Road X Slope (%)	3.8	N/A	Clear Space to XWalk (in)	N/A
N/A	Any Obstructions?	N/A	N/A	Storm Grate/Utility Hazard?	N/A
	Obstruction Type			Storm Grate/Utility Type	
		N/A			N/A
			Yes	Surface Condition? (G/P)	Good
			No	Curb Slope (%)	18.2

Remove & Replace Curb Ramp With Two New Directional Ramps or Equivalent.
