Access Compliance Report Public Rights-of-Way (Curb Ramps)

Intersection ID: N/AMain Street:BERE_ISLAND_DRCross Street: N/ALocation:NWADA ID: 0C41B1C21801Ramp Type:PerpInitial Pass/Fail:FailOverall Compliance: NoSeverity Score:10

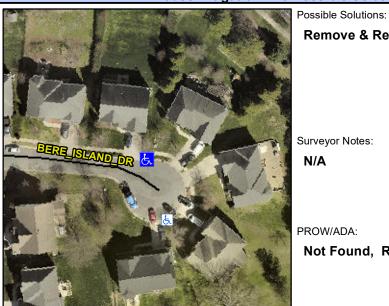
Not Found, R304.5.1, R304.5.3

Field Measurements/Component Compliance						
Comp	iance Description	Data	Compl	iance Description	n	Data
N/A	Ramp Length (in)	47.0	Yes	Ramp Slope (%)		7.6
No	Ramp Width (in)	42.0	No	Ramp XSlope (%)	ı	2.3
N/A	Flare Type LT	N/A	N/A	Flare Type RT		N/A
N/A	Flare Slope LT (%)	N/A	N/A	Flare Slope RT (%	(a)	N/A
N/A	Flare Traversable LT?	N/A	N/A	Flare Traversable	RT?	N/A
N/A	Landing Length (in)	N/A	N/A	DWS Provided?		N/A
N/A	Landing Width (in)	N/A	N/A	DWS Contrast?		N/A
N/A	Landing Slope (%)	N/A	N/A	DWS Length (in)		N/A
N/A	Landing X Slope (%)	N/A	N/A	DWS Full Width?		N/A
N/A	Landing Curb? (Y/N)	N/A	N/A	DWS Offset (in)		N/A
N/A	Shared Landing?	N/A				
N/A	Gutter Ponding?	N/A	N/A	Gutter Slope (%)		N/A
N/A	Gutter Lip Ht (in)	N/A	N/A	Gutter X Slope (%	o)	N/A
N/A	Painted X Walk1?	No	N/A	Painted X Walk2?		N/A
	X Walk 1 Direction	To SE		X Walk 2 Direction	า	N/A
N/A	X Walk 1 Width (in)	N/A	N/A	X Walk 2 Width (ir	۱)	N/A
	X Walk 1 Slope (%)	3.0		X Walk 2 Slope (%	6)	N/A

X Walk 1 X Slope (%)	0.6		X Walk 2 X Slope	(%)	N/A
N/A	Ramp inside XWalk1?	N/A	N/A	Ramp inside XWa	lk2?	N/A
	Road Slope (%)	N/A	N/A	Clear Space?		N/A
	Road X Slope (%)	N/A	N/A	Clear Space to XV	Valk (in)	N/A
N/A	Any Obstructions?	N/A	N/A	Storm Grate/Utility	/ Hazard?	N/A
	Obstruction Type			Storm Grate/Utility	/ Туре	
		N/A				N/A
			Yes	Surface Condition	? (G/P)	Good
	4

Remove & Replace Entire Ramp.

Total Cost: \$ 1850.00
