Access Compliance Report

Public Rights-of-Way

(Curb Ramps)

Intersection ID: 8619	Main Street: HATERAS_AV	Cross Street: JENNINGS_ST	Location: NW
ADA ID: 0C47A54364E4	Ramp Type: Perp	Initial Pass/Fail: Pass	Overall Compliance: No
Severity Score: 10			
Codes/Mitigation Info/Possible Solution		Field Measurements/Component Compliance

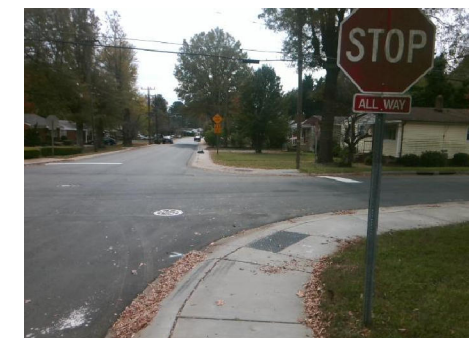
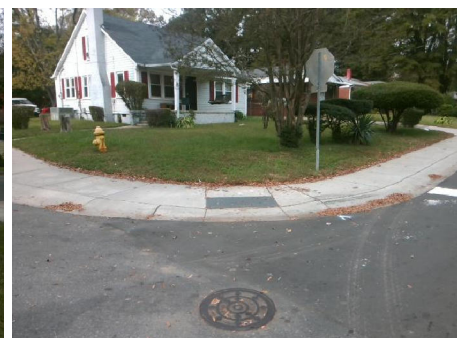
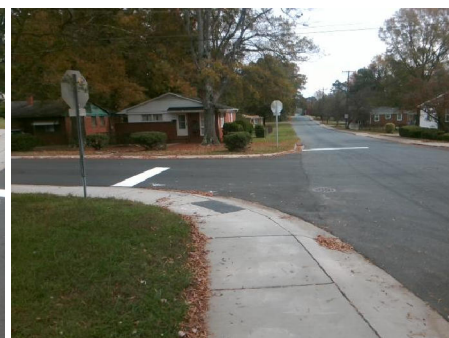
Not Found, R304.2.1, R304.2.2-Perp, R304.3.2-Para, R304.5.3

Compliance	Description	Data	Compliance	Description	Data
N/A	Ramp Length (in)	58.5	Yes	Ramp Slope (%)	6.8
Yes	Ramp Width (in)	48.0	Yes	Ramp XSlope (%)	0.8
N/A	Flare Type LT	Sloped	N/A	Flare Type RT	N/A
N/A	Flare Slope LT (%)	5.5	Yes	Flare Slope RT (%)	7.8
N/A	Flare Traversable LT?	Yes	N/A	Flare Traversable RT?	Yes
No	Landing Length (in)	N/A	Yes	DWS Provided?	Yes
No	Landing Width (in)	N/A	Yes	DWS Contrast?	Yes
No	Landing Slope (%)	N/A	Yes	DWS Length (in)	24.0
No	Landing X Slope (%)	N/A	Yes	DWS Full Width?	Yes
N/A	Landing Curb? (Y/N)	No	Yes	DWS Offset (in)	2.0
N/A	Shared Landing?	No			
Yes	Gutter Ponding?	No	Yes	Gutter Slope (%)	0.0
Yes	Gutter Lip Ht (in)	0.0	Yes	Gutter X Slope (%)	0.9
N/A	Painted X Walk1?	No	N/A	Painted X Walk2?	N/A
	X Walk 1 Direction	To S		X Walk 2 Direction	N/A
N/A	X Walk 1 Width (in)	N/A	N/A	X Walk 2 Width (in)	N/A
	X Walk 1 Slope (%)	0.9		X Walk 2 Slope (%)	N/A
	X Walk 1 X Slope (%)	1.9		X Walk 2 X Slope (%)	N/A

N/A	Ramp inside XWalk1?	N/A	N/A	Ramp inside XWalk2?	N/A
	Road Slope (%)	N/A	N/A	Clear Space?	Yes
	Road X Slope (%)	N/A	N/A	Clear Space to XWalk (in)	N/A
Yes	Any Obstructions?	No	Yes	Storm Grate/Utility Hazard?	No
	Obstruction Type			Storm Grate/Utility Type	
		N/A			N/A
		Yes	Yes	Surface Condition? (G/P)	Good

Remove & Replace Entire Ramp.
