# Access Compliance Report

## Public Rights-of-Way

### (Curb Ramps)

Intersection ID: 10144	Main Street: FONTANA_AV	Cross Street: VOGEL_CT	Location: S
ADA ID: 0C4C90CC38BD	Ramp Type: Perp	Initial Pass/Fail: Fail	Overall Compliance: No
		Severity Score: 12.5

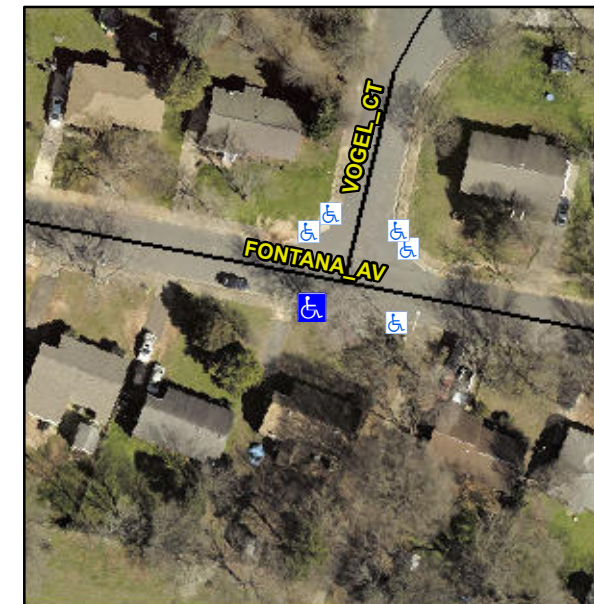
Compliance	Description	Data	Compliance	Description	Data
N/A	Ramp Length (in)	60.0	No	Ramp Slope (%)	10.8
Yes	Ramp Width (in)	48.0	Yes	Ramp XSlope (%)	0.8
N/A	Flare Type LT	N/A	N/A	Flare Type RT	N/A
N/A	Flare Slope LT (%)	N/A	N/A	Flare Slope RT (%)	N/A
N/A	Flare Traversable LT?	N/A	N/A	Flare Traversable RT?	N/A
N/A	Landing Length (in)	N/A	N/A	DWS Provided?	N/A
N/A	Landing Width (in)	N/A	N/A	DWS Contrast?	N/A
N/A	Landing Slope (%)	N/A	N/A	DWS Length (in)	N/A
N/A	Landing X Slope (%)	N/A	N/A	DWS Full Width?	N/A
N/A	Landing Curb? (Y/N)	N/A	N/A	DWS Offset (in)	N/A
N/A	Shared Landing?	N/A			
N/A	Gutter Ponding?	N/A	N/A	Gutter Slope (%)	N/A
N/A	Gutter Lip Ht (in)	0.5	N/A	Gutter X Slope (%)	N/A
N/A	Painted X Walk1?	No	N/A	Painted X Walk2?	N/A
	X Walk 1 Direction	To NW		X Walk 2 Direction	N/A
N/A	X Walk 1 Width (in)	N/A	N/A	X Walk 2 Width (in)	N/A
	X Walk 1 Slope (%)	2.3		X Walk 2 Slope (%)	N/A
	X Walk 1 X Slope (%)	0.6		X Walk 2 X Slope (%)	N/A

**Remove & Replace Entire Ramp.**

**Not Found, R304.2.2**

Total Cost: \$ 1850.00
