# Access Compliance Report

## Public Rights-of-Way

### (Curb Ramps)

| Intersection ID: 46200 | Main Street: LOROPETALUM_RD | Cross Street: FERNSPRAY_RD | Location: NW |

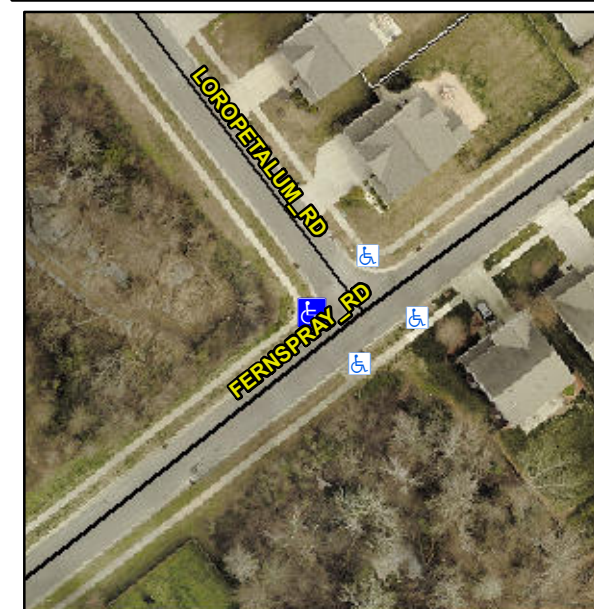
| ADA ID: 0C4D7DED6E6B | Ramp Type: PerpDiag | Initial Pass/Fail: Fail | Overall Compliance: No |
| Severity Score: 10 | | | |

**Not Found, R304.5.1, R304.5.3**

| Compliance | Description | Data | Compliance | Description | Data |
|---|---|---|---|---|---|
| N/A | Ramp Length (in) | 74.0 | Yes | Ramp Slope (%) | 6.6 |
| No | Ramp Width (in) | 47.0 | No | Ramp XSlope (%) | 2.2 |
| N/A | Gutter Lip Ht (in) | 1.0 | N/A | Gutter X Slope (%) | N/A |

**Remove & Replace Curb Ramp With Two New Directional Ramps or Equivalent.**

Total Cost: \$ 3200.00
