Access Compliance Report

Public Rights-of-Way

(Curb Ramps)

Intersection ID: 11463	Main Street: ABERDEEN_ST	Cross Street: WHITEHALL_DR	Location:	W
ADA ID: 0C517BA20370	Ramp Type: Perp	Initial Pass/Fail: Fail	Overall Compliance: No	Severity Score: 25
Codes/Mitigation Info/Possible Solution		Field Measurements/Component Compliance

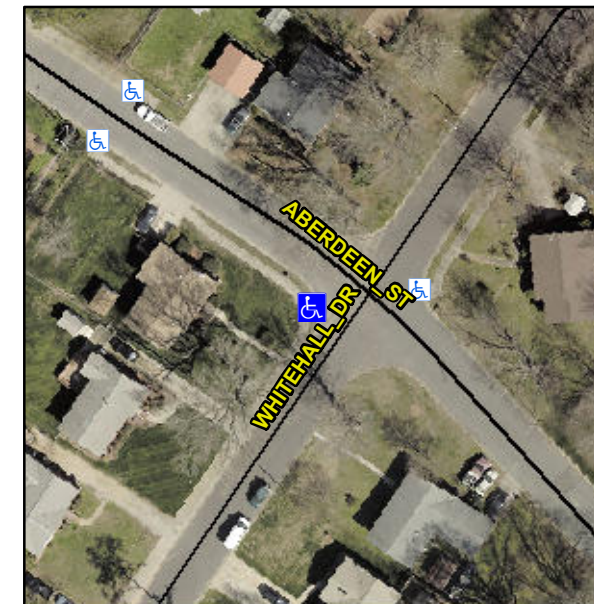
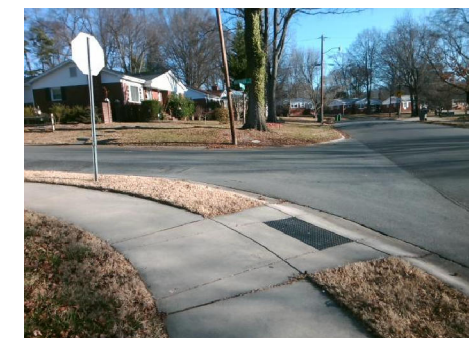
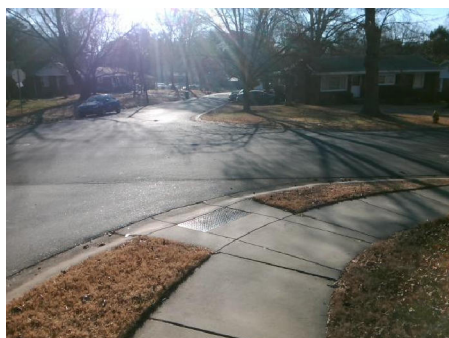
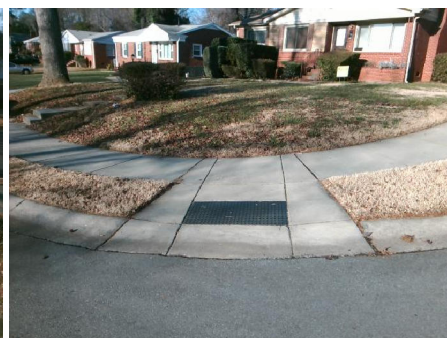
Not Found, R304.5.3

Compliance	Description	Data	Compliance	Description	Data
N/A	Ramp Length (in)	48.0	Yes	Ramp Slope (%)	6.9
Yes	Ramp Width (in)	48.0	No	Ramp XSlope (%)	8.5
N/A	Flare Type LT	N/A	N/A	Flare Type RT	N/A
N/A	Flare Slope LT (%)	N/A	N/A	Flare Slope RT (%)	N/A
N/A	Flare Traversable LT?	N/A	N/A	Flare Traversable RT?	N/A
N/A	Landing Length (in)	N/A	N/A	DWS Provided?	N/A
N/A	Landing Width (in)	N/A	N/A	DWS Contrast?	N/A
N/A	Landing Slope (%)	N/A	N/A	DWS Length (in)	N/A
N/A	Landing X Slope (%)	N/A	N/A	DWS Full Width?	N/A
N/A	Landing Curb? (Y/N)	N/A	N/A	DWS Offset (in)	N/A
N/A	Shared Landing?	N/A			
N/A	Gutter Ponding?	N/A	N/A	Gutter Slope (%)	N/A
N/A	Gutter Lip Ht (in)	N/A	N/A	Gutter X Slope (%)	N/A
N/A	Painted X Walk1?	No	N/A	Painted X Walk2?	N/A
	X Walk 1 Direction	To SE		X Walk 2 Direction	N/A
N/A	X Walk 1 Width (in)	N/A	N/A	X Walk 2 Width (in)	N/A
	X Walk 1 Slope (%)	1.1		X Walk 2 Slope (%)	N/A
	X Walk 1 X Slope (%)	7.1		X Walk 2 X Slope (%)	N/A

N/A	Ramp inside XWalk1?	N/A	N/A	Ramp inside XWalk2?	N/A
	Road Slope (%)	7.1	N/A	Clear Space?	N/A
	Road X Slope (%)	1.1	N/A	Clear Space to XWalk (in)	N/A
N/A	Any Obstructions?	N/A	N/A	Storm Grate/Utility Hazard?	N/A
	Obstruction Type			Storm Grate/Utility Type	
		N/A			N/A
			Yes	Surface Condition? (G/P)	Good

Possible Solutions:

Remove & Replace Entire Ramp.
