Access Compliance Report

Public Rights-of-Way

(Curb Ramps)

Intersection ID: 29793	Main Street: BRISTLE_TOE_LN	Cross Street: DESTIN_LN	Location: SW
ADA ID: 0C5717D9C59A	Ramp Type: PerpDiag	Initial Pass/Fail: Fail	Overall Compliance: No
		Severity Score: 50

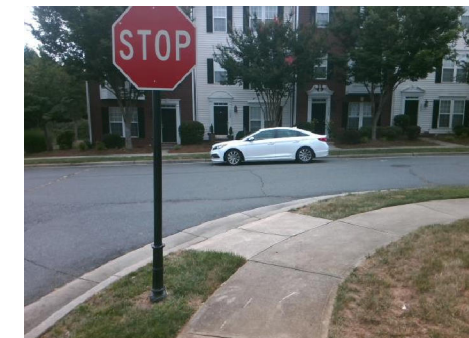
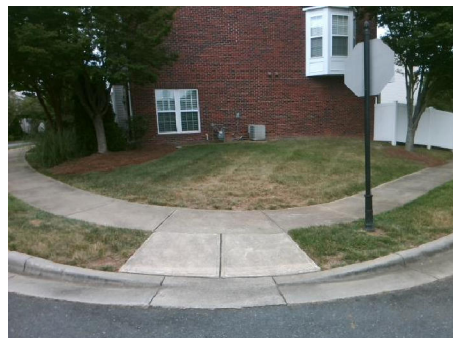
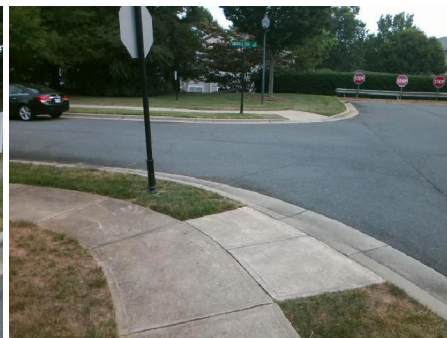
Compliance	Description	Data	Compliance	Description	Data
N/A	Ramp Length (in)	96.0	No	Ramp Slope (%)	12.3
Yes	Ramp Width (in)	48.0	No	Ramp XSlope (%)	7.5
N/A	Flare Type LT	N/A	N/A	Flare Type RT	N/A
N/A	Flare Slope LT (%)	N/A	N/A	Flare Slope RT (%)	N/A
N/A	Flare Traversable LT?	N/A	N/A	Flare Traversable RT?	N/A
N/A	Landing Length (in)	N/A	N/A	DWS Provided?	N/A
N/A	Landing Width (in)	N/A	N/A	DWS Contrast?	N/A
N/A	Landing Slope (%)	N/A	N/A	DWS Length (in)	N/A
N/A	Landing X Slope (%)	N/A	N/A	DWS Full Width?	N/A
N/A	Landing Curb? (Y/N)	N/A	N/A	DWS Offset (in)	N/A
N/A	Shared Landing?	N/A			
N/A	Gutter Ponding?	N/A	N/A	Gutter Slope (%)	N/A
N/A	Gutter Lip Ht (in)	N/A	N/A	Gutter X Slope (%)	N/A
N/A	Painted X Walk1?	No	N/A	Painted X Walk2?	No
	X Walk 1 Direction	To SE		X Walk 2 Direction	To NE
N/A	X Walk 1 Width (in)	N/A	N/A	X Walk 2 Width (in)	N/A
	X Walk 1 Slope (%)	3.0		X Walk 2 Slope (%)	3.9
	X Walk 1 X Slope (%)	2.5		X Walk 2 X Slope (%)	0.1

N/A	Ramp inside XWalk1?	N/A	N/A	Ramp inside XWalk2?	N/A
	Road Slope (%)	3.4	N/A	Clear Space?	N/A
	Road X Slope (%)	0.5	N/A	Clear Space to XWalk (in)	N/A
N/A	Any Obstructions?	N/A	N/A	Storm Grate/Utility Hazard?	N/A
	Obstruction Type			Storm Grate/Utility Type	
		N/A			N/A
			Yes	Surface Condition? (G/P)	Good

Remove & Replace Curb Ramp With Two New Directional Ramps or Equivalent.

R304.2.2, R304.5.3
