Access Compliance Report

Public Rights-of-Way

(Curb Ramps)

Intersection ID: 43497	Main Street: DALTREY_LN	Cross Street: CARANNA_CT	Location: SW
ADA ID: 0C5D2010BE4D	Ramp Type: PerpDiag	Initial Pass/Fail: Fail	Overall Compliance: No
		Severity Score: 21.25

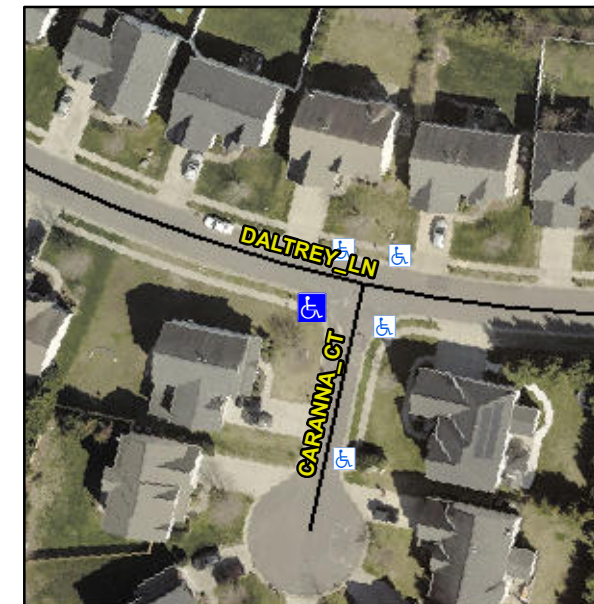
Not Found, R304.5.1, R304.5.3

Compliance	Description	Data	Compliance	Description	Data
N/A	Ramp Length (in)	51.0	Yes	Ramp Slope (%)	6.5
No	Ramp Width (in)	38.0	No	Ramp XSlope (%)	6.7
N/A	Flare Type LT	N/A	N/A	Flare Type RT	N/A
N/A	Flare Slope LT (%)	N/A	N/A	Flare Slope RT (%)	N/A
N/A	Flare Traversable LT?	N/A	N/A	Flare Traversable RT?	N/A
N/A	Landing Length (in)	N/A	N/A	DWS Provided?	N/A
N/A	Landing Width (in)	N/A	N/A	DWS Contrast?	N/A
N/A	Landing Slope (%)	N/A	N/A	DWS Length (in)	N/A
N/A	Landing X Slope (%)	N/A	N/A	DWS Full Width?	N/A
N/A	Landing Curb? (Y/N)	N/A	N/A	DWS Offset (in)	N/A
N/A	Shared Landing?	N/A			
N/A	Gutter Ponding?	N/A	N/A	Gutter Slope (%)	N/A
N/A	Gutter Lip Ht (in)	N/A	N/A	Gutter X Slope (%)	N/A
N/A	Painted X Walk1?	No	N/A	Painted X Walk2?	No
	X Walk 1 Direction	To SE		X Walk 2 Direction	To NE
N/A	X Walk 1 Width (in)	N/A	N/A	X Walk 2 Width (in)	N/A
	X Walk 1 Slope (%)	2.6		X Walk 2 Slope (%)	3.4
	X Walk 1 X Slope (%)	3.2		X Walk 2 X Slope (%)	2.1

N/A	Ramp inside XWalk1?	N/A	N/A	Ramp inside XWalk2?	N/A
	Road Slope (%)	3.9	N/A	Clear Space?	N/A
	Road X Slope (%)	1.8	N/A	Clear Space to XWalk (in)	N/A
N/A	Any Obstructions?	N/A	N/A	Storm Grate/Utility Hazard?	N/A
	Obstruction Type			Storm Grate/Utility Type	
		N/A			N/A
			Yes	Surface Condition? (G/P)	Good

Remove & Replace Curb Ramp With Two New Directional Ramps or Equivalent.
