# Access Compliance Report

## Public Rights-of-Way

### (Curb Ramps)

Intersection ID: 3261	Main Street: BILLINGHAM_DR	Cross Street: MCKENDREE_WY	Location: SE
ADA ID: 0C67CD862418	Ramp Type: Perp	Initial Pass/Fail: Fail	Overall Compliance: No
Codes/Mitigation Info/Possible Solution		Field Measurements/Component Compliance

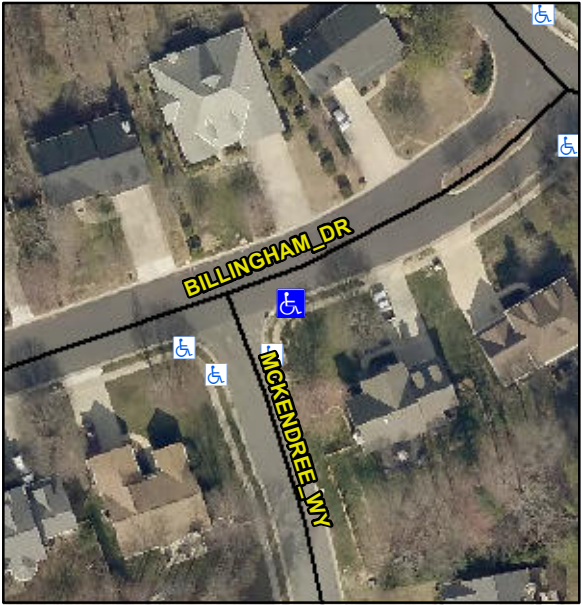
Possible Solutions:	Compliance	Description	Data	Compliance	Description	Data
	Remove & Replace Entire Ramp.	N/A	Ramp Length (in)	47.0	No	Ramp Slope (%)	9.0
		Yes	Ramp Width (in)	49.0	Yes	Ramp XSlope (%)	3.8
		N/A	Flare Type LT	N/A	N/A	Flare Type RT	N/A
		N/A	Flare Slope LT (%)	N/A	N/A	Flare Slope RT (%)	N/A
		N/A	Flare Traversable LT?	N/A	N/A	Flare Traversable RT?	N/A
		N/A	Landing Length (in)	N/A	N/A	DWS Provided?	N/A
		N/A	Landing Width (in)	N/A	N/A	DWS Contrast?	N/A
		N/A	Landing Slope (%)	N/A	N/A	DWS Length (in)	N/A
		N/A	Landing X Slope (%)	N/A	N/A	DWS Full Width?	N/A
		N/A	Landing Curb? (Y/N)	N/A	N/A	DWS Offset (in)	N/A
		N/A	Shared Landing?	N/A			
		N/A	Gutter Ponding?	N/A	N/A	Gutter Slope (%)	N/A
		N/A	Gutter Lip Ht (in)	N/A	N/A	Gutter X Slope (%)	N/A
		N/A	Painted X Walk1?	No	N/A	Painted X Walk2?	N/A
			X Walk 1 Direction	To N		X Walk 2 Direction	N/A
		N/A	X Walk 1 Width (in)	N/A	N/A	X Walk 2 Width (in)	N/A

X Walk 1 Slope (%)	4.8		X Walk 2 Slope (%)	N/A
			X Walk 1 X Slope (%)	6.0		X Walk 2 X Slope (%)	N/A
		N/A	Ramp inside XWalk1?	N/A	N/A	Ramp inside XWalk2?	N/A
<p>Surveyor Notes:</p> <p>N/A</p> <p>PROW/ADA:</p> <p>Not Found, R304.2.2</p>			Road Slope (%)	N/A	N/A	Clear Space?	N/A
			Road X Slope (%)	N/A	N/A	Clear Space to XWalk (in)	N/A
		N/A	Any Obstructions?	N/A	N/A	Storm Grate/Utility Hazard?	N/A
			Obstruction Type			Storm Grate/Utility Type	
					N/A		N/A
					Yes	Surface Condition? (G/P)	Good
