Access Compliance Report Public Rights-of-Way (Curb Ramps)

Intersection ID: 7963Main Street: ASHFORD_STCross Street: DAVID_AVLocation: N/AADA ID: 0C7303383689Ramp Type: PerpInitial Pass/Fail: FailOverall Compliance: NoSeverity Score: 22.5

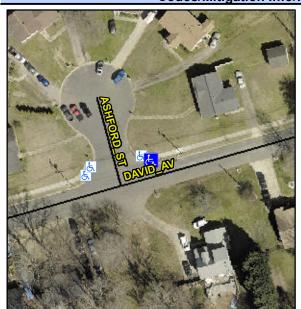
Field Measurements/Component Compliance						
Compliance Description Date		Data	Comp	liance Description	Data	
N/A	Ramp Length (in)	48.0	No	Ramp Slope (%)	8.4	
No	Ramp Width (in)	47.0	No	Ramp XSlope (%)	3.4	
N/A	Flare Type LT	N/A	N/A	Flare Type RT	N/A	
N/A	Flare Slope LT (%)	N/A	N/A	Flare Slope RT (%)	N/A	
N/A	Flare Traversable LT?	N/A	N/A	Flare Traversable RT?	N/A	
N/A	Landing Length (in)	N/A	N/A	DWS Provided?	N/A	
N/A	Landing Width (in)	N/A	N/A	DWS Contrast?	N/A	
N/A	Landing Slope (%)	N/A	N/A	DWS Length (in)	N/A	
N/A	Landing X Slope (%)	N/A	N/A	DWS Full Width?	N/A	
N/A	Landing Curb? (Y/N)	N/A	N/A	DWS Offset (in)	N/A	
N/A	Shared Landing?	N/A				
N/A	Gutter Ponding?	N/A	N/A	Gutter Slope (%)	N/A	
N/A	Gutter Lip Ht (in)	1.5	N/A	Gutter X Slope (%)	N/A	
N/A	Painted X Walk1?	No	N/A	Painted X Walk2?	N/A	
	X Walk 1 Direction	To S		X Walk 2 Direction	N/A	
N/A	X Walk 1 Width (in)	N/A	N/A	X Walk 2 Width (in)	N/A	
	X Walk 1 Slope (%)	6.0		X Walk 2 Slope (%)	N/A

X Walk 1 X Slope (%)	2.7		X Walk 2 X Slope (%)	N/A	
N/A	Ramp inside XWalk1?	N/A	N/A	Ramp inside XWalk2?	N/A	
	Road Slope (%)	2.7	N/A	Clear Space?	N/A	
	Road X Slope (%)	6.0	N/A	Clear Space to XWalk (in)	N/A	
N/A	Any Obstructions?	N/A	N/A	Storm Grate/Utility Hazard?	N/A	
	Obstruction Type			Storm Grate/Utility Type		
		N/A			N/A	
			Yes	Surface Condition? (G/P)	Good

Possible Solutions:					
Remove & Replace Entire Ramp.					
Surveyor Notes:					
N/A					
N/A					
PROW/ADA:					
Not Found, R304.5.1, R304.2.2,					
R304.5.3
