Access Compliance Report

Public Rights-of-Way

(Curb Ramps)

Intersection ID: 16004	Main Street: ROSEHALL_DR	Cross Street: ROSENA_DR	Location: SW
ADA ID: 0C75D1F18BD9	Ramp Type: PerpDiag	Initial Pass/Fail: Fail	Overall Compliance: No
Severity Score: 8.75			
Codes/Mitigation Info/Possible Solution		Field Measurements/Component Compliance

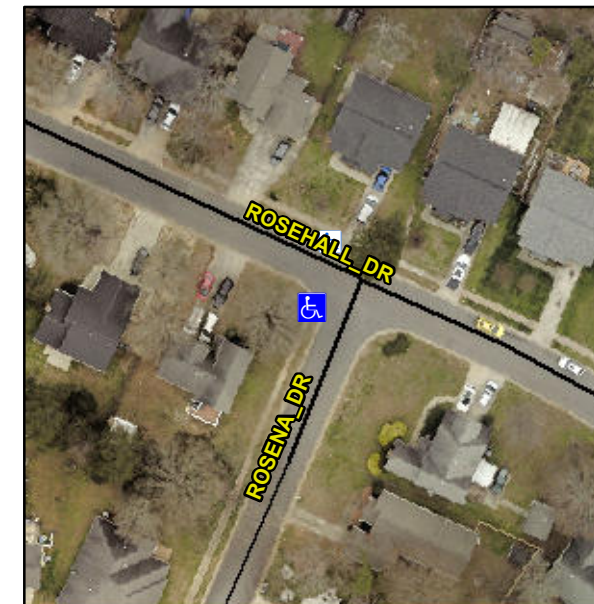
Not Found, R304.5.1

Compliance	Description	Data	Compliance	Description	Data
N/A	Ramp Length (in)	49.0	Yes	Ramp Slope (%)	8.3
No	Ramp Width (in)	46.5	Yes	Ramp XSlope (%)	0.6
N/A	Flare Type LT	N/A	N/A	Flare Type RT	N/A
N/A	Flare Slope LT (%)	N/A	N/A	Flare Slope RT (%)	N/A
N/A	Flare Traversable LT?	N/A	N/A	Flare Traversable RT?	N/A
N/A	Landing Length (in)	N/A	N/A	DWS Provided?	N/A
N/A	Landing Width (in)	N/A	N/A	DWS Contrast?	N/A
N/A	Landing Slope (%)	N/A	N/A	DWS Length (in)	N/A
N/A	Landing X Slope (%)	N/A	N/A	DWS Full Width?	N/A
N/A	Landing Curb? (Y/N)	N/A	N/A	DWS Offset (in)	N/A
N/A	Shared Landing?	N/A			
N/A	Gutter Ponding?	N/A	N/A	Gutter Slope (%)	N/A
N/A	Gutter Lip Ht (in)	N/A	N/A	Gutter X Slope (%)	N/A
N/A	Painted X Walk1?	No	N/A	Painted X Walk2?	No
	X Walk 1 Direction	To NE		X Walk 2 Direction	To SE
N/A	X Walk 1 Width (in)	N/A	N/A	X Walk 2 Width (in)	N/A
	X Walk 1 Slope (%)	2.2		X Walk 2 Slope (%)	2.5
	X Walk 1 X Slope (%)	2.4		X Walk 2 X Slope (%)	0.8

N/A	Ramp inside XWalk1?	N/A	N/A	Ramp inside XWalk2?	N/A
	Road Slope (%)	0.8	N/A	Clear Space?	N/A
	Road X Slope (%)	1.8	N/A	Clear Space to XWalk (in)	N/A
N/A	Any Obstructions?	N/A	N/A	Storm Grate/Utility Hazard?	N/A
	Obstruction Type			Storm Grate/Utility Type	
		N/A			N/A
			Yes	Surface Condition? (G/P)	Good

Possible Solutions:

Remove & Replace Curb Ramp With Two New Directional Ramps or Equivalent.
