# Access Compliance Report

## Public Rights-of-Way

### (Curb Ramps)

Intersection ID: 10027864	Main Street: HAMILTON_ST	Cross Street: N/A	Location: NE
ADA ID: 0C789CC4A092	Ramp Type: Perp	Initial Pass/Fail: Fail	Overall Compliance: No
Severity Score: 10			
Codes/Mitigation Info/Possible Solution		Field Measurements/Component Compliance

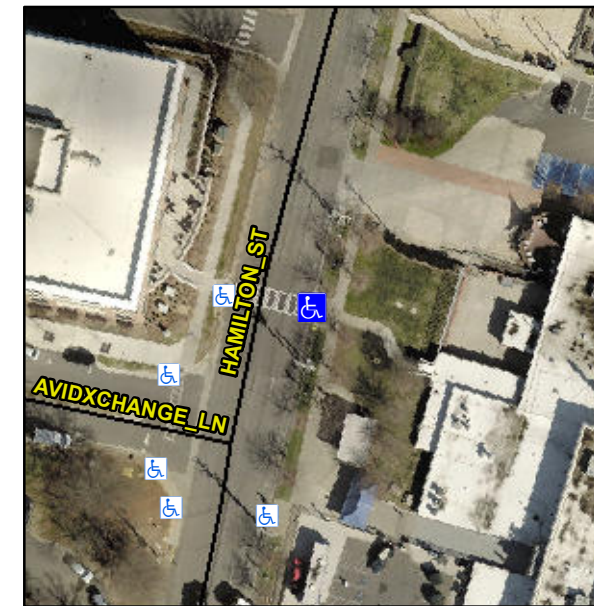
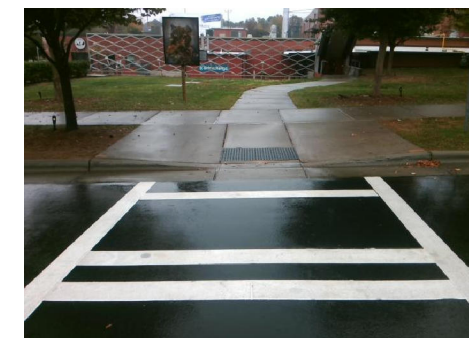
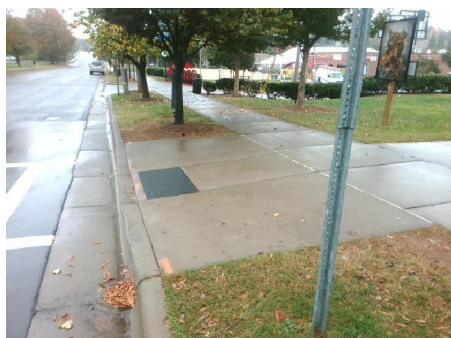
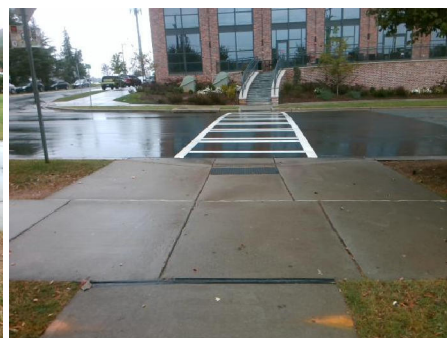
Compliance	Description	Data	Compliance	Description	Data
N/A	Ramp Length (in)	96.0	Yes	Ramp Slope (%)	5.4
No	Ramp Width (in)	47.5	Yes	Ramp XSlope (%)	3.3
N/A	Flare Type LT	N/A	N/A	Flare Type RT	N/A
N/A	Flare Slope LT (%)	N/A	N/A	Flare Slope RT (%)	N/A
N/A	Flare Traversable LT?	N/A	N/A	Flare Traversable RT?	N/A
N/A	Landing Length (in)	N/A	N/A	DWS Provided?	N/A
N/A	Landing Width (in)	N/A	N/A	DWS Contrast?	N/A
N/A	Landing Slope (%)	N/A	N/A	DWS Length (in)	N/A
N/A	Landing X Slope (%)	N/A	N/A	DWS Full Width?	N/A
N/A	Landing Curb? (Y/N)	N/A	N/A	DWS Offset (in)	N/A
N/A	Shared Landing?	N/A			
N/A	Gutter Ponding?	N/A	N/A	Gutter Slope (%)	N/A
N/A	Gutter Lip Ht (in)	N/A	N/A	Gutter X Slope (%)	N/A
N/A	Painted X Walk1?	Yes	N/A	Painted X Walk2?	N/A
	X Walk 1 Direction	To W		X Walk 2 Direction	N/A
N/A	X Walk 1 Width (in)	104.0	N/A	X Walk 2 Width (in)	N/A
	X Walk 1 Slope (%)	2.7		X Walk 2 Slope (%)	N/A
	X Walk 1 X Slope (%)	4.0		X Walk 2 X Slope (%)	N/A

N/A	Ramp inside XWalk1?	Yes	N/A	Ramp inside XWalk2?	N/A
	Road Slope (%)	N/A	N/A	Clear Space?	N/A
	Road X Slope (%)	N/A	N/A	Clear Space to XWalk (in)	N/A
N/A	Any Obstructions?	N/A	N/A	Storm Grate/Utility Hazard?	N/A
	Obstruction Type			Storm Grate/Utility Type	
		N/A			N/A
			Yes	Surface Condition? (G/P)	Good

Possible Solutions:

**Remove & Replace Entire Ramp.**

**R304.5.1**

**\$ 1850.00**
