| Intersection ID: 20630 | Main Street: COUNTRY_BARN_CT | Cross Street: EMERALD_MEADOW_LN | Location: | W |
| ADA ID: 0C7B5FCA150E | Ramp Type: PerpDiag | Initial Pass/Fail: Fail | Overall Compliance: No | Severity Score: 13.75 |

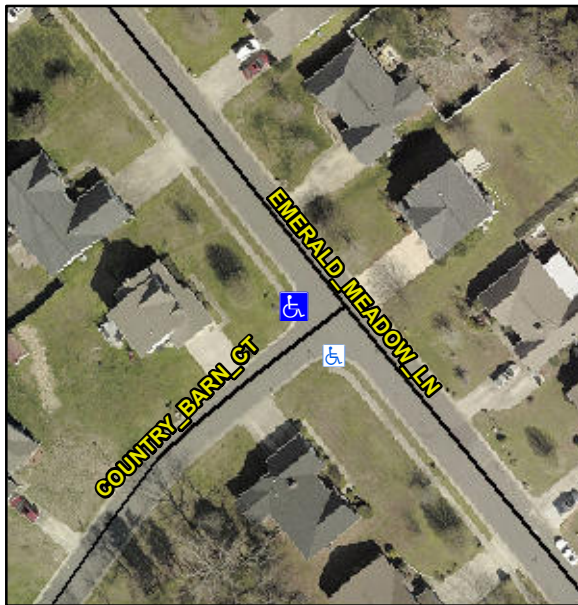
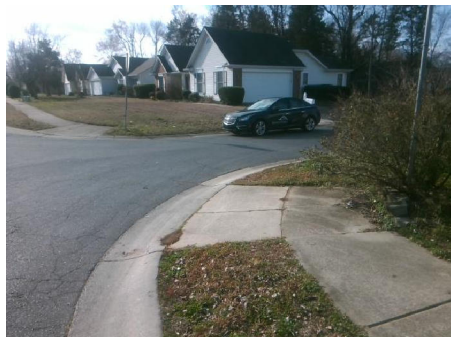
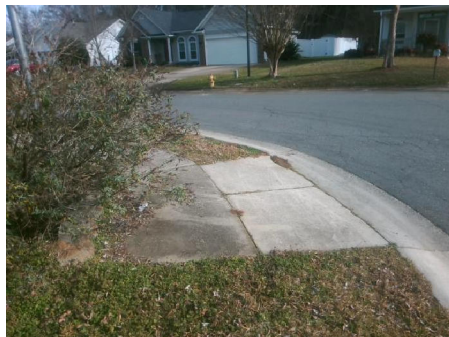
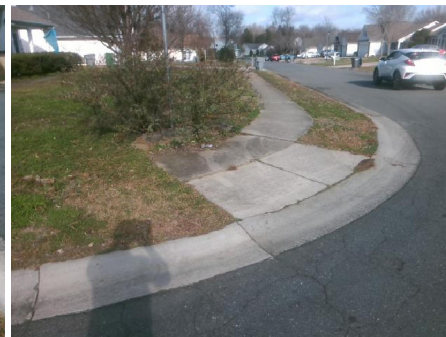
| Compliance | Description | Data | Compliance | Description | Data |
|---|---|---|---|---|---|
| N/A | Ramp Length (in) | 48.0 | No | Ramp Slope (%) | 9.5 |
| Yes | Ramp Width (in) | 48.0 | No | Ramp XSlope (%) | 2.6 |

Remove & Replace Curb Ramp With Two New Directional Ramps or Equivalent.

R304.2.2, R304.5.3
