# Access Compliance Report

## Public Rights-of-Way

### (Curb Ramps)

| Intersection ID: 14482 | Main Street: WALLACE_AV | Cross Street: WALLACE_GLEN_DR | Location: SE |

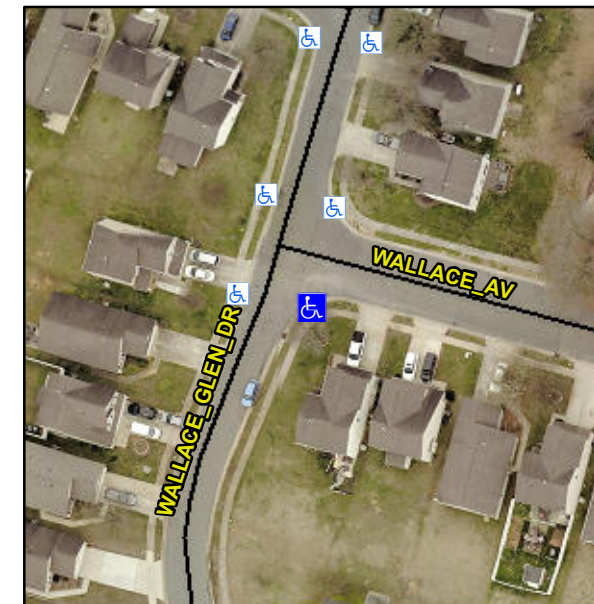
| ADA ID: 0C8D0E2A089D | Ramp Type: BlendTrans1 | Initial Pass/Fail: Fail | Overall Compliance: No |

**Not Found, R304.5.1**

| Compliance | Description | Data | Compliance | Description | Data |
|---|---|---|---|---|---|
| No | Ramp Width (in) | 34.0 | Yes | BlendTrans XSlope (%) | 1.0 |
| | | | No | Curb Slope (%) | 8.4 |

**Remove & Replace Curb Ramp With Two New Directional Ramps or Equivalent.**
