# Access Compliance Report

## Public Rights-of-Way

| Intersection ID: 30436 | Main Street: MARIANNES RIDGE RD | Cross Street: STEELE MEADOW RD | Location: NW |
| ADA ID: 0C905E8C4429 | Ramp Type: BlendTrans1 | Initial Pass/Fail: Pass | Overall Compliance: No |

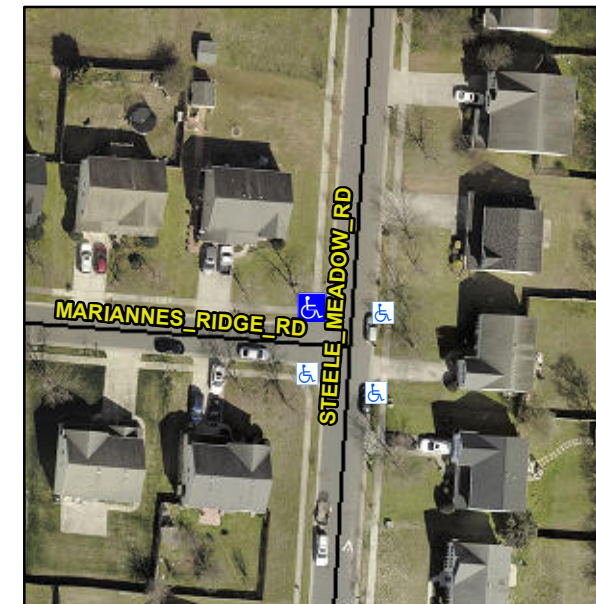
| Severity Score: 10 | | | |

**R304.2.1, R304.5.3, R305**

| Compliance | Description | Data | Compliance | Description | Data |
|---|---|---|---|---|---|
| No | Landing Length (in) | 47.0 | No | DWS Provided? | No |
| No | Landing X Slope (%) | 2.5 | N/A | DWS Full Width? | No |

**Remove & Replace Curb Ramp With Two New Directional Ramps or Equivalent.**

Total Cost: \$ 3200.00
