# Access Compliance Report

## Public Rights-of-Way

### (Curb Ramps)

Intersection ID: 13085	Main Street: MORRIS_FIELD_DR	Cross Street: CAPITOL_DR	Location: W
ADA ID: 0C954D4CAB86	Ramp Type: Perp	Initial Pass/Fail: Fail	Overall Compliance: No
Severity Score: 12.5			
Codes/Mitigation Info/Possible Solution		Field Measurements/Component Compliance

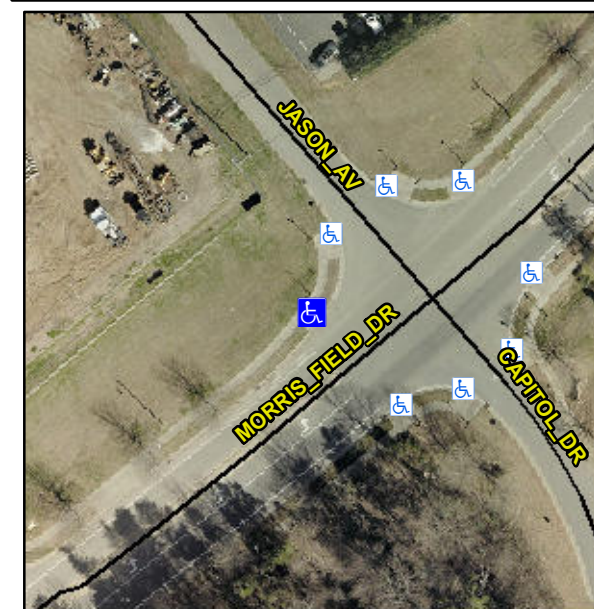
Compliance	Description	Data	Compliance	Description	Data
N/A	Ramp Length (in)	71.0	Yes	Ramp Slope (%)	7.6
Yes	Ramp Width (in)	48.0	No	Ramp XSlope (%)	5.4
N/A	Flare Type LT	N/A	N/A	Flare Type RT	N/A
N/A	Flare Slope LT (%)	N/A	N/A	Flare Slope RT (%)	N/A
N/A	Flare Traversable LT?	N/A	N/A	Flare Traversable RT?	N/A
N/A	Landing Length (in)	N/A	N/A	DWS Provided?	N/A
N/A	Landing Width (in)	N/A	N/A	DWS Contrast?	N/A
N/A	Landing Slope (%)	N/A	N/A	DWS Length (in)	N/A
N/A	Landing X Slope (%)	N/A	N/A	DWS Full Width?	N/A
N/A	Landing Curb? (Y/N)	N/A	N/A	DWS Offset (in)	N/A
N/A	Shared Landing?	N/A			
N/A	Gutter Ponding?	N/A	N/A	Gutter Slope (%)	N/A
N/A	Gutter Lip Ht (in)	N/A	N/A	Gutter X Slope (%)	N/A
N/A	Painted X Walk1?	No	N/A	Painted X Walk2?	N/A
	X Walk 1 Direction	To SE		X Walk 2 Direction	N/A
N/A	X Walk 1 Width (in)	N/A	N/A	X Walk 2 Width (in)	N/A
	X Walk 1 Slope (%)	1.3		X Walk 2 Slope (%)	N/A
	X Walk 1 X Slope (%)	2.1		X Walk 2 X Slope (%)	N/A

N/A	Ramp inside XWalk1?	N/A	N/A	Ramp inside XWalk2?	N/A
	Road Slope (%)	N/A	N/A	Clear Space?	N/A
	Road X Slope (%)	N/A	N/A	Clear Space to XWalk (in)	N/A
N/A	Any Obstructions?	N/A	N/A	Storm Grate/Utility Hazard?	N/A
	Obstruction Type			Storm Grate/Utility Type	
		N/A			N/A
			Yes	Surface Condition? (G/P)	Good

Possible Solutions:

**Remove & Replace Entire Ramp.**

**R304.5.3**

**\$ 1850.00**
