Access Compliance Report

Public Rights-of-Way

(Curb Ramps)

Intersection ID: N/A	Main Street: REA_RD	Cross Street: N/A	Location: SE
ADA ID: 0C9642F6C623	Ramp Type: Perp	Initial Pass/Fail: Fail	Overall Compliance: No
Severity Score: 21.25			
Codes/Mitigation Info/Possible Solution		Field Measurements/Component Compliance

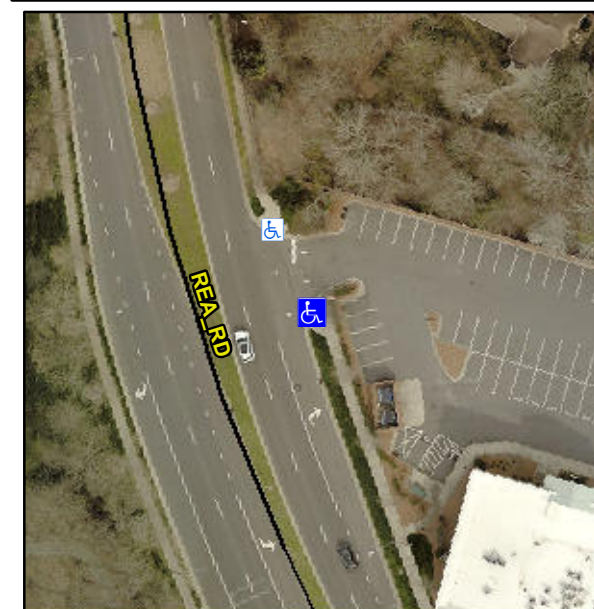
Compliance	Description	Data	Compliance	Description	Data
N/A	Ramp Length (in)	130.0	Yes	Ramp Slope (%)	6.4
No	Ramp Width (in)	47.0	No	Ramp XSlope (%)	5.2
N/A	Flare Type LT	N/A	N/A	Flare Type RT	N/A
N/A	Flare Slope LT (%)	N/A	N/A	Flare Slope RT (%)	N/A
N/A	Flare Traversable LT?	N/A	N/A	Flare Traversable RT?	N/A
N/A	Landing Length (in)	N/A	N/A	DWS Provided?	N/A
N/A	Landing Width (in)	N/A	N/A	DWS Contrast?	N/A
N/A	Landing Slope (%)	N/A	N/A	DWS Length (in)	N/A
N/A	Landing X Slope (%)	N/A	N/A	DWS Full Width?	N/A
N/A	Landing Curb? (Y/N)	N/A	N/A	DWS Offset (in)	N/A
N/A	Shared Landing?	N/A			
N/A	Gutter Ponding?	N/A	N/A	Gutter Slope (%)	N/A
N/A	Gutter Lip Ht (in)	N/A	N/A	Gutter X Slope (%)	N/A
N/A	Painted X Walk1?	No	N/A	Painted X Walk2?	N/A
	X Walk 1 Direction	To N		X Walk 2 Direction	N/A
N/A	X Walk 1 Width (in)	N/A	N/A	X Walk 2 Width (in)	N/A
	X Walk 1 Slope (%)	2.2		X Walk 2 Slope (%)	N/A
	X Walk 1 X Slope (%)	2.8		X Walk 2 X Slope (%)	N/A

N/A	Ramp inside XWalk1?	N/A	N/A	Ramp inside XWalk2?	N/A
	Road Slope (%)	N/A	N/A	Clear Space?	N/A
	Road X Slope (%)	N/A	N/A	Clear Space to XWalk (in)	N/A
N/A	Any Obstructions?	N/A	N/A	Storm Grate/Utility Hazard?	N/A
	Obstruction Type			Storm Grate/Utility Type	
		N/A			N/A
			Yes	Surface Condition? (G/P)	Good

Remove & Replace Entire Ramp.

R304.5.1, R304.5.3
