Access Compliance Report

Public Rights-of-Way

(Curb Ramps)

Intersection ID: 2878	Main Street: BROKEN_PINE_LN	Cross Street: LONG_FOREST_DR	Location: SE
ADA ID: 0C9CACA14543	Ramp Type: Perp	Initial Pass/Fail: Pass	Overall Compliance: No
		Severity Score: 0	
Codes/Mitigation Info/Possible Solution		Field Measurements/Component Compliance

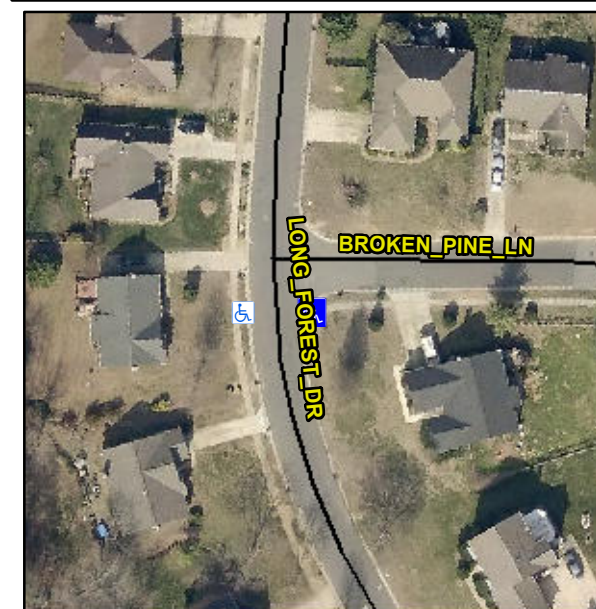
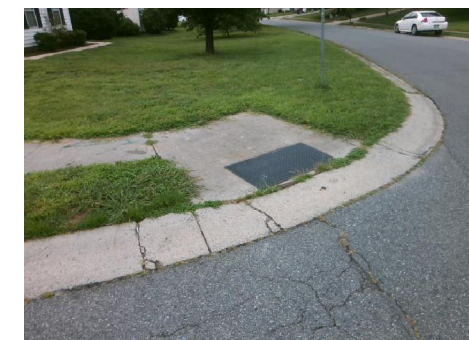
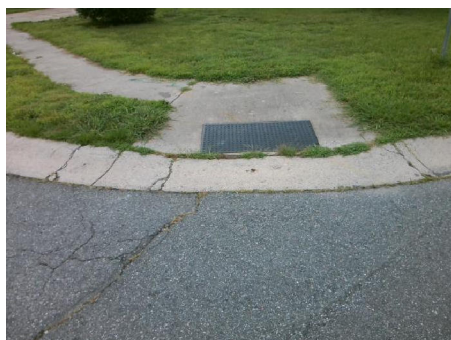
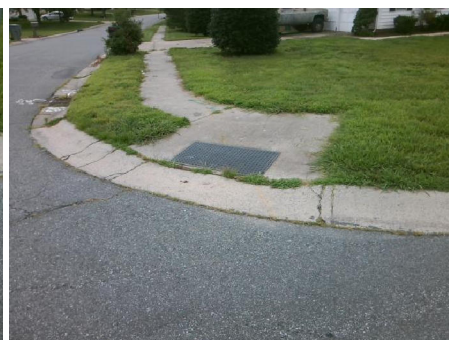
Compliance	Description	Data	Compliance	Description	Data
N/A	Ramp Length (in)	52.0	Yes	Ramp Slope (%)	7.7
Yes	Ramp Width (in)	48.0	Yes	Ramp XSlope (%)	0.3
N/A	Flare Type LT	Sloped	N/A	Flare Type RT	N/A
N/A	Flare Slope LT (%)	15.5	N/A	Flare Slope RT (%)	16.1
N/A	Flare Traversable LT?	No	N/A	Flare Traversable RT?	No
No	Landing Length (in)	45.0	Yes	DWS Provided?	Yes
Yes	Landing Width (in)	48.0	Yes	DWS Contrast?	Yes
No	Landing Slope (%)	3.0	Yes	DWS Length (in)	25.5
Yes	Landing X Slope (%)	0.1	Yes	DWS Full Width?	Yes
N/A	Landing Curb? (Y/N)	No	No	DWS Offset (in)	4.0
N/A	Shared Landing?	No			
Yes	Gutter Ponding?	No	Yes	Gutter Slope (%)	1.4
Yes	Gutter Lip Ht (in)	0.0	Yes	Gutter X Slope (%)	0.3
N/A	Painted X Walk1?	No	N/A	Painted X Walk2?	N/A
	X Walk 1 Direction	To W		X Walk 2 Direction	N/A
N/A	X Walk 1 Width (in)	N/A	N/A	X Walk 2 Width (in)	N/A
	X Walk 1 Slope (%)	3.3		X Walk 2 Slope (%)	N/A
	X Walk 1 X Slope (%)	5.8		X Walk 2 X Slope (%)	N/A

N/A	Ramp inside XWalk1?	N/A	N/A	Ramp inside XWalk2?	N/A
	Road Slope (%)	N/A	N/A	Clear Space?	Yes
	Road X Slope (%)	N/A	N/A	Clear Space to XWalk (in)	N/A
Yes	Any Obstructions?	No	Yes	Storm Grate/Utility Hazard?	No
	Obstruction Type			Storm Grate/Utility Type	
		N/A			N/A
			Yes	Surface Condition? (G/P)	Good

Possible Solutions:

Remove & Replace Entire Ramp.

R304.2.1, R304.2.2-Perp, R304.3.2-Para, R305.2
