# Access Compliance Report

## Public Rights-of-Way

### (Curb Ramps)

Intersection ID: 11917	Main Street: MIMOSA_AV	Cross Street: THURMOND_PL	Location: SW
ADA ID: 0C9D7B2D3248	Ramp Type: Para	Initial Pass/Fail: Fail	Overall Compliance: No
Codes/Mitigation Info/Possible Solution			Severity Score: 25
			Field Measurements/Component Compliance

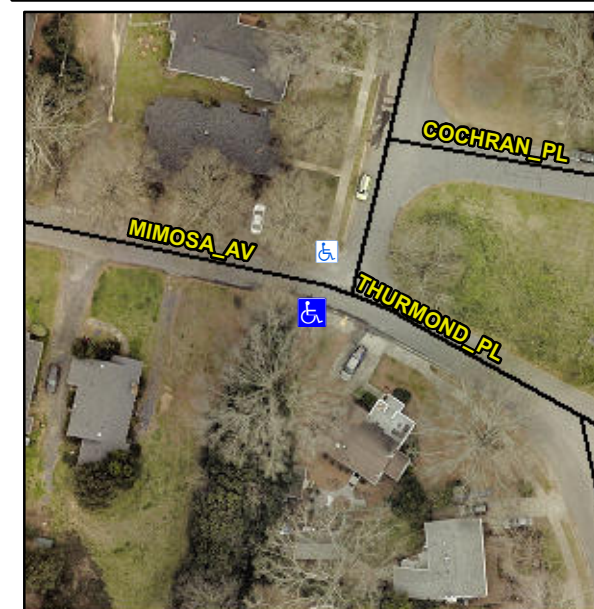
**LT RP < 5%**

**R304.3.2**

Compliance	Description	Data	Compliance	Description	Data
N/A	Ramp Length LT (in)	64.5	N/A	Ramp Length RT (in)	69.0
Yes	Ramp Width LT (in)	72.0	Yes	Ramp Width RT (in)	72.0
Yes	Ramp Slope LT (%)	2.6	No	Ramp Slope RT (%)	12.2
Yes	Ramp XSlope LT (%)	1.5	Yes	Ramp XSlope RT (%)	2.0
N/A	Landing Length (in)	N/A	N/A	DWS Provided?	N/A
N/A	Landing Width (in)	N/A	N/A	DWS Contrast?	N/A
N/A	Landing Slope (%)	N/A	N/A	DWS Length (in)	N/A
N/A	Landing X Slope (%)	N/A	N/A	DWS Full Width?	N/A
N/A	Landing Curb? (Y/N)	N/A	N/A	DWS Offset (in)	N/A
N/A	Shared Landing?	N/A			
N/A	Gutter Ponding?	N/A	N/A	Gutter Slope (%)	N/A
N/A	Gutter Lip Ht (in)	N/A	N/A	Gutter X Slope (%)	N/A
N/A	Painted X Walk1?	No	N/A	Painted X Walk2?	N/A
	X Walk 1 Direction	To N		X Walk 2 Direction	N/A
N/A	X Walk 1 Width (in)	N/A	N/A	X Walk 2 Width (in)	N/A
	X Walk 1 Slope (%)	0.5		X Walk 2 Slope (%)	N/A
	X Walk 1 X Slope (%)	3.3		X Walk 2 X Slope (%)	N/A
N/A	Ramp inside XWalk1?	N/A	N/A	Ramp inside XWalk2?	N/A

Road Slope (%)	N/A	N/A	Clear Space?	N/A
	Road X Slope (%)	N/A	N/A	Clear Space to XWalk (in)	N/A
N/A	Any Obstructions?	N/A	N/A	Storm Grate/Utility Hazard?	N/A
	Obstruction Type			Storm Grate/Utility Type	
		N/A			N/A
			Yes	Surface Condition? (G/P)	Good
			N/A	Curb Slope (%)	0.1

**Remove & Replace Entire Ramp.**

**\$ 1600.00**
