# Access Compliance Report

## Public Rights-of-Way

### (Curb Ramps)

| Intersection ID: 11256 | Main Street: N_IRWIN_AV | Cross Street: W_5TH_ST | Location: E |

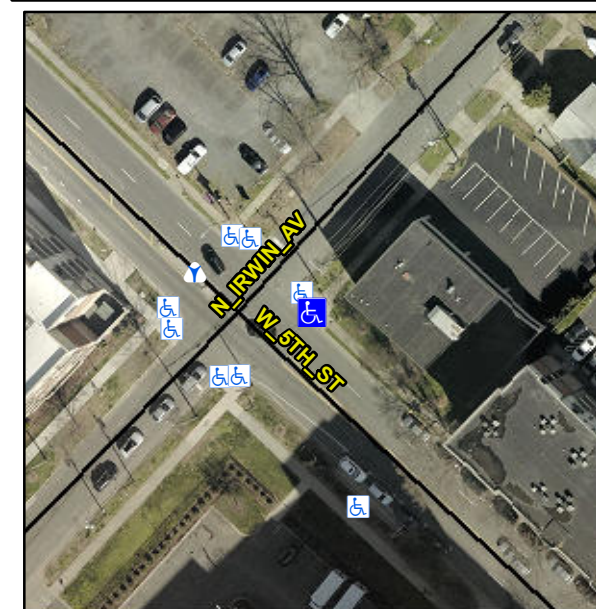
**Not Found, R304.5.3, R304.5.4**

| Compliance | Description | Data | Compliance | Description | Data |
|---|---|---|---|---|---|
| Yes | Ramp Width (in) | 48.0 | No | BlendTrans XSlope (%) | 3.4 |
| No | Landing X Slope (%) | 4.5 | Yes | DWS Full Width? | Yes |
| Yes | Gutter Ponding? | No | No | Gutter Slope (%) | 5.3 |
| Yes | Gutter Lip Ht (in) | 0.0 | No | Gutter X Slope (%) | 3.1 |
| | | | No | Curb Slope (%) | 15.4 |

**Remove & Replace Curb Ramp With Two New Directional Ramps or Equivalent. Remove & Replace Gutter.**
