Access Compliance Report Public Rights-of-Way (Curb Ramps)

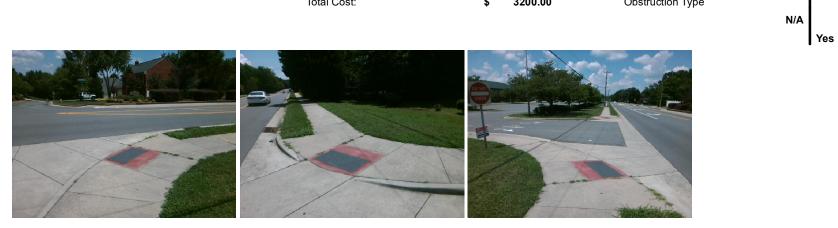
· · · · · · · · · · · · · · · · · · ·									
Intersection ID: 27019 Main St		eet: ENDHAVEN_LN	Cross	Cross Street: ROUGEMONT_LN				Location:	SE
ADA ID: 0CA05082CE1A Ramp Ty		Type: PerpDiag		Initial Pass/Fail: Pass Overall Complia			nce: N	o Severity Score:	10.25
Codes/Mitigation Info/Possible Solution				Field Measurements/Component Compliance					
		Possible Solutions:		Compliance Description		Data Compliance Description			Data
		Remove & Replace Curb Ramp	With	N/A	Ramp Length (in)	87.0	Yes	Ramp Slope (%)	7.5
		Two New Directional Ramps or		Yes	Ramp Width (in)	56.0	No	Ramp XSlope (%)	2.4
		Equivalent.		N/A	Flare Type LT	Sloped	N/A	Flare Type RT	N/A
NI INO				N/A	Flare Slope LT (%)	8.6	Yes	Flare Slope RT (%)	3.2
E B				N/A	Flare Traversable LT?	Yes	N/A	Flare Traversable RT?	Yes
				No	Landing Length (in)	N/A	Yes	DWS Provided?	Yes
		Surveyor Notes:		No	Landing Width (in)	N/A	Yes	DWS Contrast?	Yes

k. t	A Charles	N/A		No	Landing Slope (%)	N/A	Yes	DWS Length (in)	24.0
the appropriate the second second	the second a second			No	Landing X Slope (%)	N/A	Yes	DWS Full Width?	Yes
	· · ·			N/A	Landing Curb? (Y/N)	No	No	DWS Offset (in)	7.0
	Melling 1			N/A	Shared Landing?	N/A			
ALLAN		PROW/ADA:		Yes	Gutter Ponding?	No	Yes	Gutter Slope (%)	2.0
		R304.5.3, R304.2.1, R304.2.2-Perg	rp.	Yes	Gutter Lip Ht (in)	0.0	Yes	Gutter X Slope (%)	0.4
		R304.3.2-Para, R305.2	- P ,	N/A	Painted X Walk1?	No	N/A	Painted X Walk2?	No
	· · ··································				X Walk 1 Direction	To NE		X Walk 2 Direction	To NW
				N/A	X Walk 1 Width (in)	N/A	N/A	X Walk 2 Width (in)	N/A
Street 1 Name	ENTRANCE	-			X Walk 1 Slope (%)	0.0		X Walk 2 Slope (%)	2.5
Stop Condition-Street 2	None				X Walk 1 X Slope (%)	2.9		X Walk 2 X Slope (%)	2.1
Street 2 Name	ROUGEMONT LN			N/A	Ramp inside XWalk1?	N/A	N/A	Ramp inside XWalk2?	N/A
Stop Condition-Street 1	StopSign				Road Slope (%)	0.9	N/A	Clear Space?	Yes

Road X Slope (%)	2.9	N/A	Clear Space to XWalk (in)	N/A
				Yes	Any Obstructions?	No	Yes	Storm Grate/Utility Hazard?	No
		Total Cost: \$	3200.00		Obstruction Type			Storm Grate/Utility Type	
						N/A			N/A

es Surface Condition? (G/P)

Good
