# Access Compliance Report

## Public Rights-of-Way

### (Curb Ramps)

Intersection ID: 54423		Main Street: BLARNEY_RIDGE_DR		Cross Street: KILKENNY_DR		Location:		N	
ADA ID: 0CAC0D106CEC		Ramp Type: Directional1		Initial Pass/Fail: Fail		Overall Compliance: No		Severity Score: 25	
Codes/Mitigation Info/Possible Solution				Field Measurements/Component Compliance					
<div>

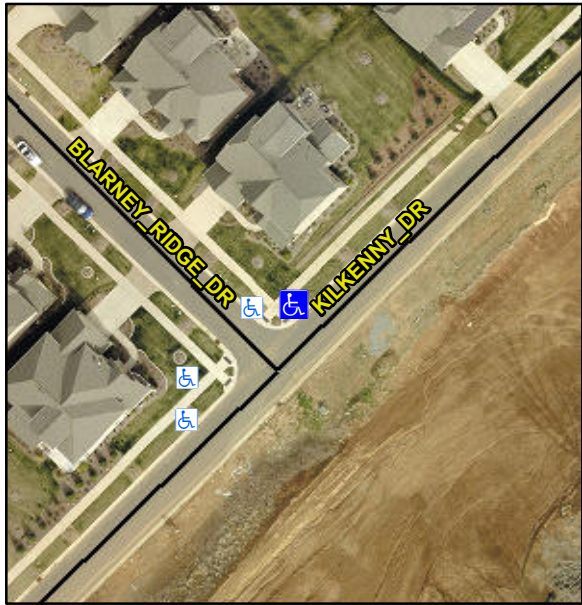
</div> <div>Possible Solutions:</div> <div>Remove &amp; Replace Entire Ramp.</div> <div>Surveyor Notes:</div> <div>N/A</div> <div>PROW/ADA:</div> <div>R304.2.2</div> <div>Street 1 Name</div> <div>KILKENNY DR</div> <div>Stop Condition-Street 1</div> <div>None</div> <div>Street 2 Name</div> <div>N/A</div> <div>Stop Condition-Street 2</div> <div>N/A</div> <div>Total Cost:</div> <div>\$</div> <div>1600.00</div>				Compliance	Description	Data	Compliance	Description	Data
				N/A	Ramp Length (in)	80.5	N/A	Grade Break?	N/A
				Yes	Ramp Width (in)	60.0	N/A	Grade Break Slope (%)	0.0
				No	Ramp Slope (%)	12.5	N/A	Grade Break XSlope (%)	0.0

Yes	Ramp XSlope (%)	1.2			
				N/A	Flare Type LT	N/A	N/A	Flare Type RT	N/A
				N/A	Flare Slope LT (%)	N/A	N/A	Flare Slope RT (%)	0.0
				N/A	Flare Traversable LT?	N/A	N/A	Flare Traversable RT?	N/A
				N/A	Landing Length (in)	0.0	N/A	DWS Provided?	N/A
				N/A	Landing Width (in)	0.0	N/A	DWS Contrast?	N/A
				N/A	Landing Slope (%)	0.0	N/A	DWS Length (in)	N/A
				N/A	Landing X Slope (%)	0.0	N/A	DWS Full Width?	N/A
				N/A	Landing Curb? (Y/N)	N/A	N/A	DWS Offset LT (in)	N/A
				N/A	Shared Landing?	N/A	N/A	DWS Offset RT (in)	N/A
				N/A	Gutter Ponding?	0.0	N/A	Gutter Slope (%)	N/A
				N/A	Gutter Lip Ht (in)	0.0	N/A	Gutter X Slope (%)	N/A
				N/A	Painted X Walk1?	No		Road Slope (%)	3.0
					X Walk 1 Direction	To SE		Road X Slope (%)	4.7
					X Walk 1 Width (in)	N/A		Clear Space?	N/A
					X Walk 1 Slope (%)	3.0	N/A	Clear Space to XWalk (in)	N/A
					X Walk 1 X Slope (%)	4.7	N/A	Storm Grate/Utility Hazard?	N/A

N/A	Ramp inside XWalk1?	N/A		Storm Grate/Utility Type	
				N/A	Any Obstructions?	N/A			N/A
					Obstruction Type		Yes	Surface Condition? (G/P)	Good
							N/A	Curb Slope (%)	1.5
