Access Compliance Report Public Rights-of-Way (Curb Ramps)

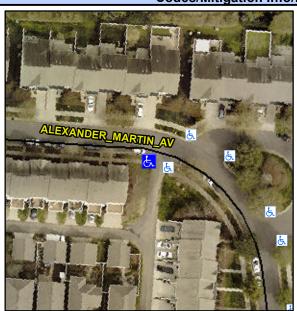
Total Cost:	\$ 3200.00

Field Measurements/Component Compliance							
Comp	liance Description	Data	Comp	liance Description	Data		
N/A	Ramp Length (in)	87.0	No	Ramp Slope (%)	10.1		
Yes	Ramp Width (in)	50.0	Yes	Ramp XSlope (%)	1.2		
N/A	Flare Type LT	N/A	N/A	Flare Type RT	N/A		
N/A	Flare Slope LT (%)	N/A	N/A	Flare Slope RT (%)	N/A		
N/A	Flare Traversable LT?	N/A	N/A	Flare Traversable RT?	N/A		
N/A	Landing Length (in)	N/A	N/A	DWS Provided?	N/A		
N/A	Landing Width (in)	N/A	N/A	DWS Contrast?	N/A		
N/A	Landing Slope (%)	N/A	N/A	DWS Length (in)	N/A		
N/A	Landing X Slope (%)	N/A	N/A	DWS Full Width?	N/A		
N/A	Landing Curb? (Y/N)	N/A	N/A	DWS Offset (in)	N/A		
N/A	Shared Landing?	N/A					
N/A	Gutter Ponding?	N/A	N/A	Gutter Slope (%)	N/A		
N/A	Gutter Lip Ht (in)	N/A	N/A	Gutter X Slope (%)	N/A		
N/A	Painted X Walk1?	No	N/A	Painted X Walk2?	No		
	X Walk 1 Direction	To SE		X Walk 2 Direction	To N		
N/A	X Walk 1 Width (in)	N/A	N/A	X Walk 2 Width (in)	N/A

Street 1 Name N/A Stop Condition-Street 2 None Street 2 Name **ALEXANDER MARTIN AV** Stop Condition-Street 1 None

Possible Solutions:	
Remove & Replace Curb Ramp With Two New Directional Ramps or	
Equivalent.	I
Duminium Maton	
Surveyor Notes:	
N/A	
PROW/ADA:	
Not Found, R304.2.2
