# Access Compliance Report

## Public Rights-of-Way

### (Curb Ramps)

Intersection ID: 10027310	Main Street: GLENEAGLES_RD	Cross Street: N/A	Location: NW
ADA ID: 0CB2B540C278	Ramp Type: ParaDiag	Initial Pass/Fail: Pass	Overall Compliance: No
		Severity Score: 5

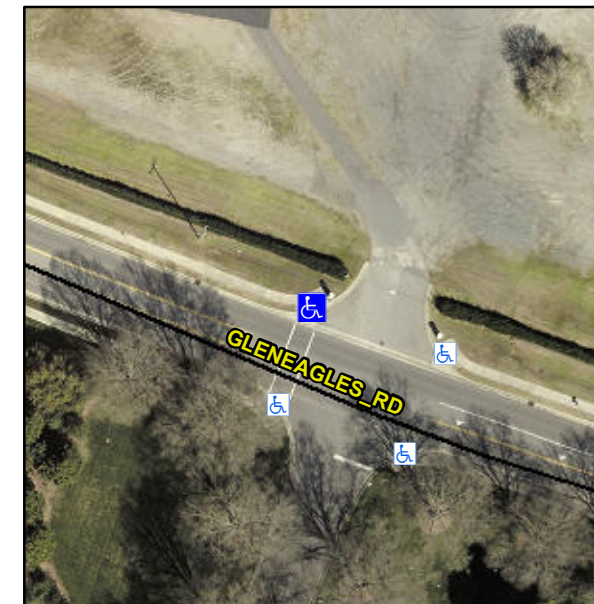
Compliance	Description	Data	Compliance	Description	Data
N/A	Ramp Length LT (in)	N/A	N/A	Ramp Length RT (in)	81.0
N/A	Ramp Width LT (in)	N/A	Yes	Ramp Width RT (in)	60.0
N/A	Ramp Slope LT (%)	N/A	Yes	Ramp Slope RT (%)	6.6
N/A	Ramp XSlope LT (%)	N/A	Yes	Ramp XSlope RT (%)	0.8
Yes	Landing Length (in)	108.0	Yes	DWS Provided?	Yes
No	Landing Width (in)	39.0	Yes	DWS Contrast?	Yes
No	Landing Slope (%)	4.1	Yes	DWS Length (in)	25.5
No	Landing X Slope (%)	2.9	Yes	DWS Full Width?	Yes
N/A	Landing Curb? (Y/N)	No	Yes	DWS Offset (in)	1.0
N/A	Shared Landing?	No			
Yes	Gutter Ponding?	No	No	Gutter Slope (%)	11.5
Yes	Gutter Lip Ht (in)	0.0	Yes	Gutter X Slope (%)	0.7
N/A	Painted X Walk1?	Yes	N/A	Painted X Walk2?	No
	X Walk 1 Direction	To SW		X Walk 2 Direction	To SE
N/A	X Walk 1 Width (in)	123.0	N/A	X Walk 2 Width (in)	N/A
	X Walk 1 Slope (%)	2.7		X Walk 2 Slope (%)	5.0
	X Walk 1 X Slope (%)	3.5		X Walk 2 X Slope (%)	5.1
Yes	Ramp inside XWalk1?	Yes	N/A	Ramp inside XWalk2?	N/A

Road Slope (%)	1.6	N/A	Clear Space?	Yes
	Road X Slope (%)	10.8	N/A	Clear Space to XWalk (in)	N/A
Yes	Any Obstructions?	No	Yes	Storm Grate/Utility Hazard?	No
	Obstruction Type			Storm Grate/Utility Type	
		N/A			N/A
			Yes	Surface Condition? (G/P)	Good
			N/A	Curb Slope (%)	4.7

**Remove & Replace Curb Ramp With Two New Directional Ramps or Equivalent. Remove & Replace Gutter.**
