# Access Compliance Report

## Public Rights-of-Way

### (Curb Ramps)

Intersection ID: N/A	Main Street: ELEANOR_RIGBY_RD	Cross Street: MOONLIGHT_BAY_WY	Location: NE
ADA ID: 0CB7AA8B42C3	Ramp Type: BlendTrans1	Initial Pass/Fail: Fail	Overall Compliance: No
		Severity Score: 10

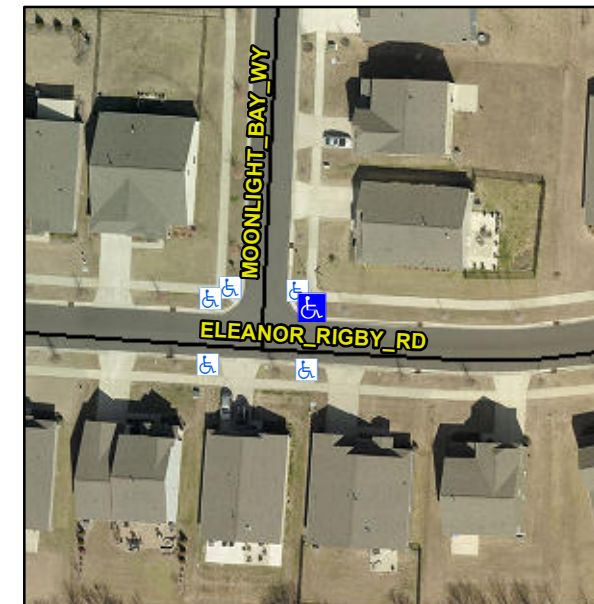
Compliance	Description	Data	Compliance	Description	Data
N/A	Ramp Length (in)	103.5	Yes	BlendTrans Slope (%)	4.6
No	Ramp Width (in)	47.0	No	BlendTrans XSlope (%)	2.2
N/A	Flare Type LT	N/A	N/A	Flare Type RT	N/A
N/A	Flare Slope LT (%)	N/A	N/A	Flare Slope RT (%)	N/A
N/A	Flare Traversable LT?	N/A	N/A	Flare Traversable RT?	N/A
N/A	Landing Length (in)	N/A	N/A	DWS Provided?	N/A
N/A	Landing Width (in)	N/A	N/A	DWS Contrast?	N/A
N/A	Landing Slope (%)	N/A	N/A	DWS Length (in)	N/A
N/A	Landing X Slope (%)	N/A	N/A	DWS Full Width?	N/A
N/A	Landing Curb? (Y/N)	N/A	N/A	DWS Offset (in)	N/A
N/A	Shared Landing?	N/A			
N/A	Gutter Ponding?	N/A	N/A	Gutter Slope (%)	N/A
N/A	Gutter Lip Ht (in)	N/A	N/A	Gutter X Slope (%)	N/A
N/A	Painted X Walk1?	No	N/A	Painted X Walk2?	N/A
	X Walk 1 Direction	To S		X Walk 2 Direction	N/A
	X Walk 1 Width (in)	N/A		X Walk 2 Width (in)	N/A
	X Walk 1 Slope (%)	3.2		X Walk 2 Slope (%)	N/A
	X Walk 1 X Slope (%)	0.8		X Walk 2 X Slope (%)	N/A

N/A	Ramp inside XWalk1?	N/A	N/A	Ramp inside XWalk2?	N/A
	Road Slope (%)	0.8		Clear Space?	N/A
	Road X Slope (%)	3.2	N/A	Clear Space to XWalk (in)	N/A
N/A	Any Obstructions?	N/A	N/A	Storm Grate/Utility Hazard?	N/A
	Obstruction Type			Storm Grate/Utility Type	
		N/A			N/A
			Yes	Surface Condition? (G/P)	Good
			N/A	Curb Slope (%)	4.0

**Remove & Replace Curb Ramp With Two New Directional Ramps or Equivalent.**

**R304.5.1, R304.5.3**
