Access Compliance Report

Public Rights-of-Way

(Curb Ramps)

Intersection ID: 23977	Main Street: REA_RD	Cross Street: WINDYRUSH_RD	Location: NW
ADA ID: 0CC1C8C06C79	Ramp Type: Perp	Initial Pass/Fail: Fail	Overall Compliance: No
Severity Score: 12.5			
Codes/Mitigation Info/Possible Solution		Field Measurements/Component Compliance

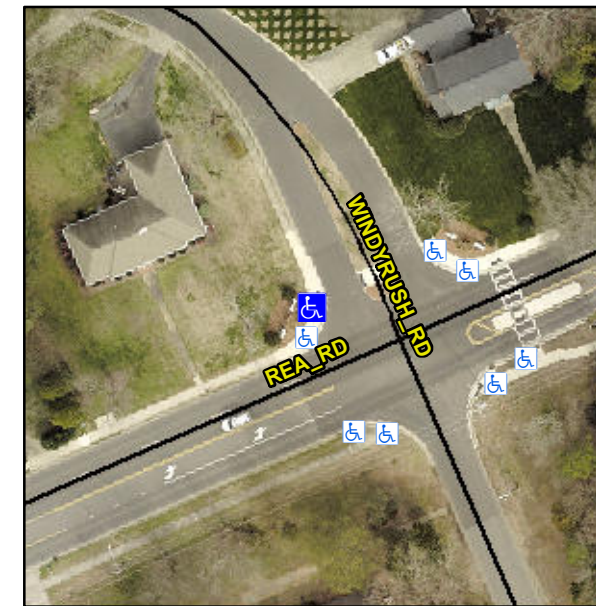
Not Found, R304.5.3

Compliance	Description	Data	Compliance	Description	Data
N/A	Ramp Length (in)	69.0	Yes	Ramp Slope (%)	7.8
Yes	Ramp Width (in)	73.0	No	Ramp XSlope (%)	5.2
N/A	Flare Type LT	N/A	N/A	Flare Type RT	N/A
N/A	Flare Slope LT (%)	N/A	N/A	Flare Slope RT (%)	N/A
N/A	Flare Traversable LT?	N/A	N/A	Flare Traversable RT?	N/A
N/A	Landing Length (in)	N/A	N/A	DWS Provided?	N/A
N/A	Landing Width (in)	N/A	N/A	DWS Contrast?	N/A
N/A	Landing Slope (%)	N/A	N/A	DWS Length (in)	N/A
N/A	Landing X Slope (%)	N/A	N/A	DWS Full Width?	N/A
N/A	Landing Curb? (Y/N)	N/A	N/A	DWS Offset (in)	N/A
N/A	Shared Landing?	N/A			
N/A	Gutter Ponding?	N/A	N/A	Gutter Slope (%)	N/A
N/A	Gutter Lip Ht (in)	N/A	N/A	Gutter X Slope (%)	N/A
N/A	Painted X Walk1?	No	N/A	Painted X Walk2?	N/A
	X Walk 1 Direction	To E		X Walk 2 Direction	N/A
N/A	X Walk 1 Width (in)	N/A	N/A	X Walk 2 Width (in)	N/A
	X Walk 1 Slope (%)	3.4		X Walk 2 Slope (%)	N/A
	X Walk 1 X Slope (%)	0.5		X Walk 2 X Slope (%)	N/A

N/A	Ramp inside XWalk1?	N/A	N/A	Ramp inside XWalk2?	N/A
	Road Slope (%)	N/A	N/A	Clear Space?	N/A
	Road X Slope (%)	N/A	N/A	Clear Space to XWalk (in)	N/A
N/A	Any Obstructions?	N/A	N/A	Storm Grate/Utility Hazard?	N/A
	Obstruction Type			Storm Grate/Utility Type	
		N/A			N/A
		Yes		Surface Condition? (G/P)	Good

Remove & Replace Entire Ramp.
