Access Compliance Report

Public Rights-of-Way

(Curb Ramps)

Intersection ID: N/A	Main Street: AGNEW_DR	Cross Street: KELBURN_LN	Location: SW
ADA ID: 0CC6096DA145	Ramp Type: BlendTrans1	Initial Pass/Fail: Fail	Overall Compliance: No
Codes/Mitigation Info/Possible Solution			Severity Score: 10
			Field Measurements/Component Compliance

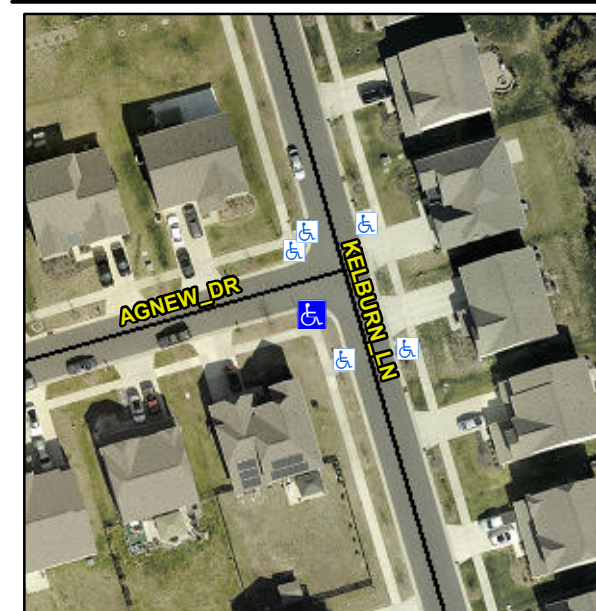
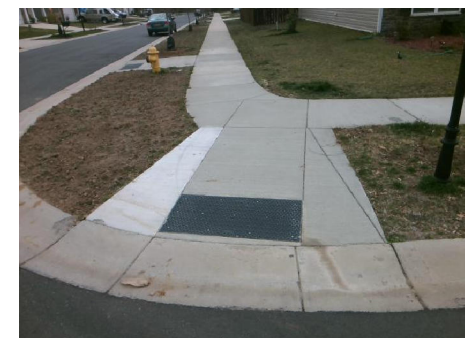
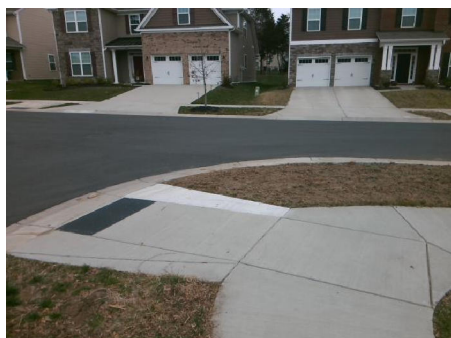
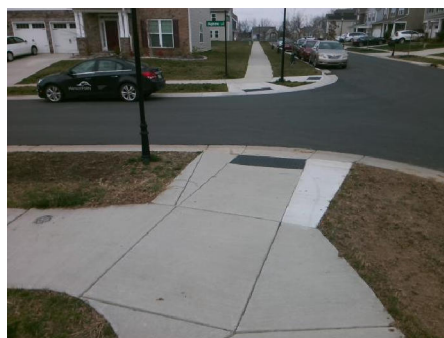
Not Found, R304.5.1, R304.5.3

Compliance	Description	Data	Compliance	Description	Data
N/A	Ramp Length (in)	101.0	Yes	BlendTrans Slope (%)	3.8
No	Ramp Width (in)	46.0	No	BlendTrans XSlope (%)	2.5
N/A	Flare Type LT	N/A	N/A	Flare Type RT	N/A
N/A	Flare Slope LT (%)	N/A	N/A	Flare Slope RT (%)	N/A
N/A	Flare Traversable LT?	N/A	N/A	Flare Traversable RT?	N/A
N/A	Landing Length (in)	N/A	N/A	DWS Provided?	N/A
N/A	Landing Width (in)	N/A	N/A	DWS Contrast?	N/A
N/A	Landing Slope (%)	N/A	N/A	DWS Length (in)	N/A
N/A	Landing X Slope (%)	N/A	N/A	DWS Full Width?	N/A
N/A	Landing Curb? (Y/N)	N/A	N/A	DWS Offset (in)	N/A
N/A	Shared Landing?	N/A			
N/A	Gutter Ponding?	N/A	N/A	Gutter Slope (%)	N/A
N/A	Gutter Lip Ht (in)	N/A	N/A	Gutter X Slope (%)	N/A
N/A	Painted X Walk1?	No	N/A	Painted X Walk2?	N/A
	X Walk 1 Direction	To N		X Walk 2 Direction	N/A
	X Walk 1 Width (in)	N/A		X Walk 2 Width (in)	N/A
	X Walk 1 Slope (%)	3.8		X Walk 2 Slope (%)	N/A
	X Walk 1 X Slope (%)	3.5		X Walk 2 X Slope (%)	N/A

N/A	Ramp inside XWalk1?	N/A	N/A	Ramp inside XWalk2?	N/A
	Road Slope (%)	3.5		Clear Space?	N/A
	Road X Slope (%)	3.8	N/A	Clear Space to XWalk (in)	N/A
N/A	Any Obstructions?	N/A	N/A	Storm Grate/Utility Hazard?	N/A
	Obstruction Type			Storm Grate/Utility Type	
		N/A			N/A
			Yes	Surface Condition? (G/P)	Good
			No	Curb Slope (%)	7.8

Remove & Replace Curb Ramp With Two New Directional Ramps or Equivalent.
