# Access Compliance Report

## Public Rights-of-Way

### (Curb Ramps)

Intersection ID: 53147	Main Street: ACHIEVEMENT_LN	Cross Street: NEW_RENAISSANCE_WY	Location: SE
ADA ID: 0CCB202768E8	Ramp Type: Directional1	Initial Pass/Fail: Fail	Overall Compliance: No
Severity Score: 1.25			
Codes/Mitigation Info/Possible Solution		Field Measurements/Component Compliance

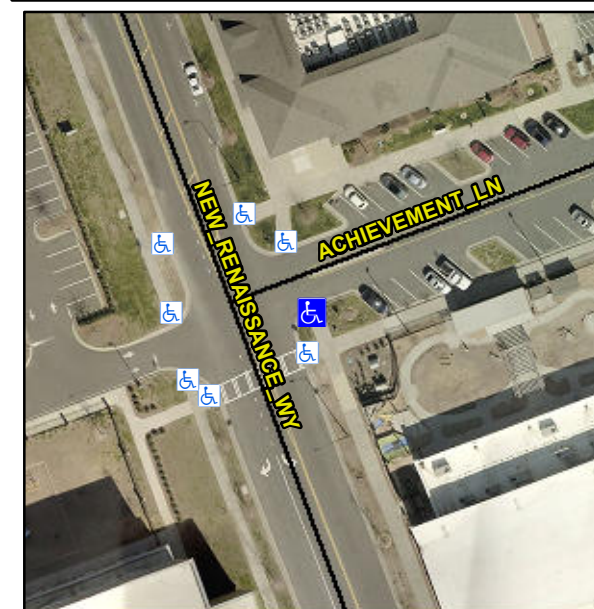
Compliance	Description	Data	Compliance	Description	Data
N/A	Ramp Length (in)	77.0	N/A	Grade Break?	N/A
Yes	Ramp Width (in)	96.0	N/A	Grade Break Slope (%)	0.0
Yes	Ramp Slope (%)	7.0	N/A	Grade Break XSlope (%)	0.0
No	Ramp XSlope (%)	3.0			
N/A	Flare Type LT	N/A	N/A	Flare Type RT	N/A
N/A	Flare Slope LT (%)	N/A	N/A	Flare Slope RT (%)	0.0
N/A	Flare Traversable LT?	N/A	N/A	Flare Traversable RT?	N/A
N/A	Landing Length (in)	0.0	N/A	DWS Provided?	N/A
N/A	Landing Width (in)	0.0	N/A	DWS Contrast?	N/A
N/A	Landing Slope (%)	0.0	N/A	DWS Length (in)	N/A
N/A	Landing X Slope (%)	0.0	N/A	DWS Full Width?	N/A
N/A	Landing Curb? (Y/N)	N/A	N/A	DWS Offset LT (in)	N/A
N/A	Shared Landing?	N/A	N/A	DWS Offset RT (in)	N/A
N/A	Gutter Ponding?	0.0	N/A	Gutter Slope (%)	N/A
N/A	Gutter Lip Ht (in)	0.0	N/A	Gutter X Slope (%)	N/A
N/A	Painted X Walk1?	No		Road Slope (%)	2.0
	X Walk 1 Direction	To NW		Road X Slope (%)	1.6
	X Walk 1 Width (in)	N/A		Clear Space?	N/A

X Walk 1 Slope (%)	2.0	N/A	Clear Space to XWalk (in)	N/A
	X Walk 1 X Slope (%)	1.6	N/A	Storm Grate/Utility Hazard?	N/A
N/A	Ramp inside XWalk1?	N/A		Storm Grate/Utility Type	
N/A	Any Obstructions?	N/A			N/A
	Obstruction Type		Yes	Surface Condition? (G/P)	Good
			N/A	Curb Slope (%)	10.5

**Remove & Replace Entire Ramp.**
