# Access Compliance Report

## Public Rights-of-Way (Curb Ramps)

| Intersection ID: 8389 | Main Street: N LINWOOD_AV | Cross Street: ROZZELLES_FERRY_RD | Location: NW |
| ADA ID: 0CD5C8A2216A | Ramp Type: Directional1 | Initial Pass/Fail: Fail | Overall Compliance: No |

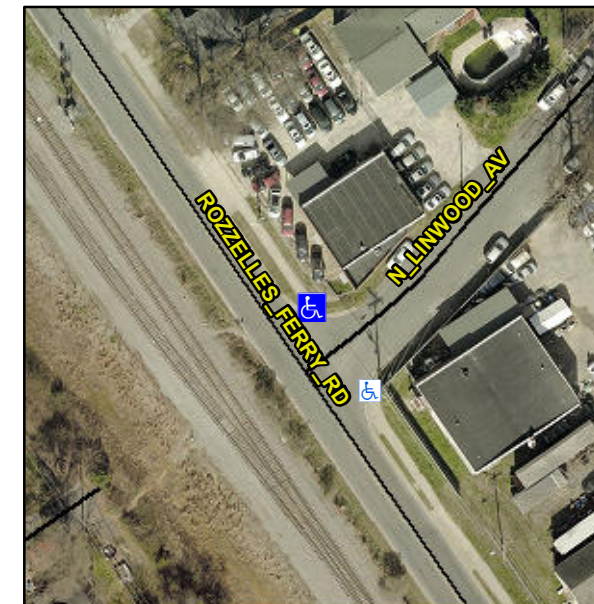
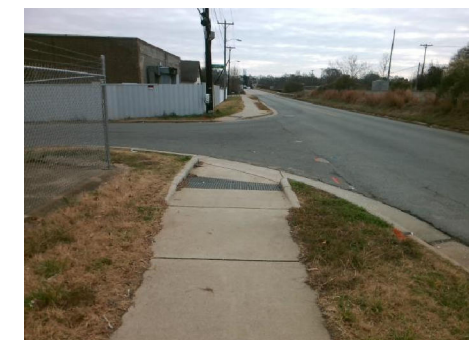
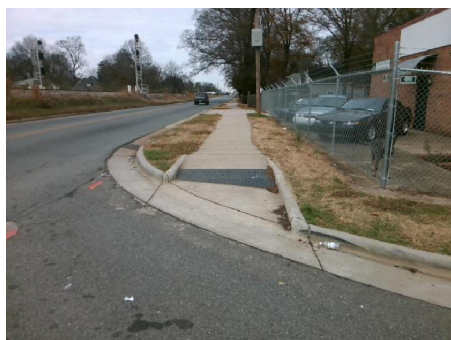
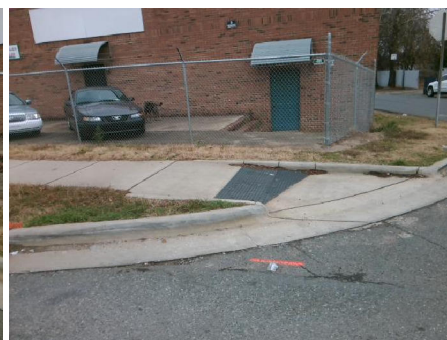
| Severity Score: 12.5 | | | |

**R304.2.2**

| Compliance | Description | Data | Compliance | Description | Data |
|---|---|---|---|---|---|
| No | Ramp Slope (%) | 9.3 | N/A | Grade Break XSlope (%) | 0.0 |

**Remove & Replace Entire Ramp.**

Total Cost: \$ 1600.00
