# Access Compliance Report

## Public Rights-of-Way

### (Curb Ramps)

| Intersection ID: 43482 | Main Street: SAFARI_CT | Cross Street: ERWIN_RD | Location: SW |

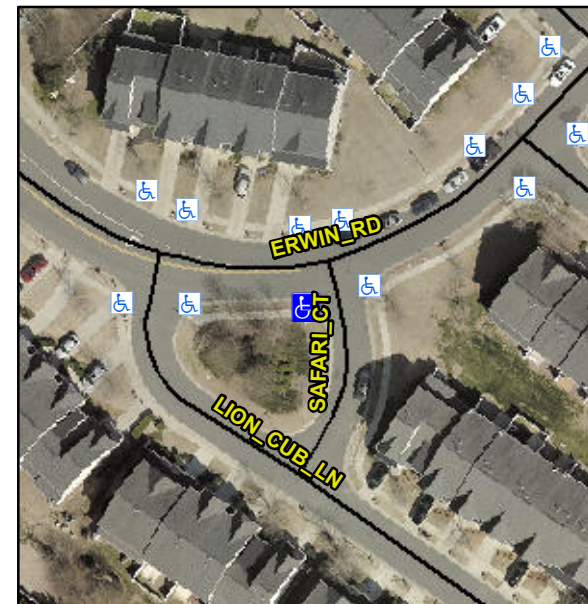
| Severity Score: 10 | | | |

**Not Found, R304.5.1, R304.5.3**

| Compliance | Description | Data | Compliance | Description | Data |
|---|---|---|---|---|---|
| N/A | Ramp Length (in) | 48.0 | Yes | Ramp Slope (%) | 5.6 |
| No | Ramp Width (in) | 47.0 | No | Ramp XSlope (%) | 4.3 |

**Remove & Replace Curb Ramp With Two New Directional Ramps or Equivalent.**
