Access Compliance Report

Public Rights-of-Way

(Curb Ramps)

Intersection ID: 6882	Main Street: STATESVILLE_RD	Cross Street: CINDY_LN	Location: SE
ADA ID: 0CDD6FE03C62	Ramp Type: Perp	Initial Pass/Fail: Fail	Overall Compliance: No
Severity Score: 17.5			
Codes/Mitigation Info/Possible Solution		Field Measurements/Component Compliance

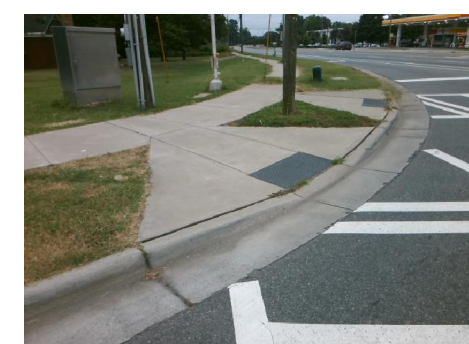
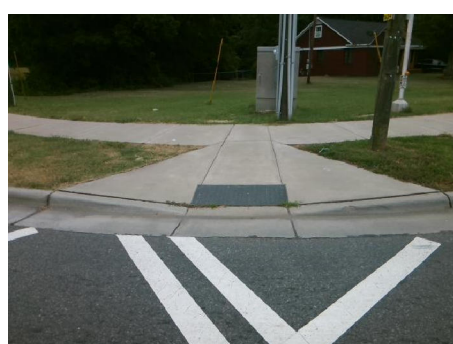
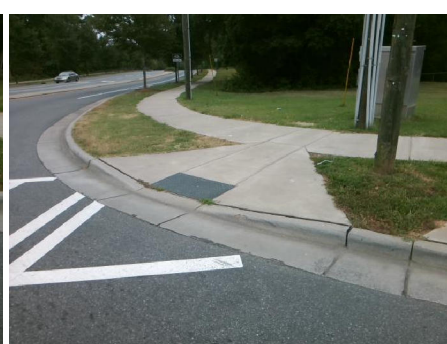
Compliance	Description	Data	Compliance	Description	Data
N/A	Ramp Length (in)	110.0	Yes	Ramp Slope (%)	7.5
No	Ramp Width (in)	35.5	Yes	Ramp XSlope (%)	1.0
N/A	Flare Type LT	N/A	N/A	Flare Type RT	N/A
N/A	Flare Slope LT (%)	N/A	N/A	Flare Slope RT (%)	N/A
N/A	Flare Traversable LT?	N/A	N/A	Flare Traversable RT?	N/A
N/A	Landing Length (in)	N/A	N/A	DWS Provided?	N/A
N/A	Landing Width (in)	N/A	N/A	DWS Contrast?	N/A
N/A	Landing Slope (%)	N/A	N/A	DWS Length (in)	N/A
N/A	Landing X Slope (%)	N/A	N/A	DWS Full Width?	N/A
N/A	Landing Curb? (Y/N)	N/A	N/A	DWS Offset (in)	N/A
N/A	Shared Landing?	N/A			
N/A	Gutter Ponding?	N/A	N/A	Gutter Slope (%)	N/A
N/A	Gutter Lip Ht (in)	N/A	N/A	Gutter X Slope (%)	N/A
N/A	Painted X Walk1?	Yes	N/A	Painted X Walk2?	N/A
	X Walk 1 Direction	To N		X Walk 2 Direction	N/A
N/A	X Walk 1 Width (in)	111.0	N/A	X Walk 2 Width (in)	N/A
	X Walk 1 Slope (%)	1.4		X Walk 2 Slope (%)	N/A
	X Walk 1 X Slope (%)	1.4		X Walk 2 X Slope (%)	N/A

N/A	Ramp inside XWalk1?	Yes	N/A	Ramp inside XWalk2?	N/A
	Road Slope (%)	N/A	N/A	Clear Space?	N/A
	Road X Slope (%)	N/A	N/A	Clear Space to XWalk (in)	N/A
N/A	Any Obstructions?	N/A	N/A	Storm Grate/Utility Hazard?	N/A
	Obstruction Type			Storm Grate/Utility Type	
		N/A			N/A
		Yes		Surface Condition? (G/P)	Good

Remove & Replace Entire Ramp.
